THE UTAH GUIDE FOR THE SEISMIC IMPROVEMENT OF UNREINFORCED MASONRY DWELLINGS

**Utah Seismic Safety Commission
Existing Buildings Committee
Second Edition
2016**

PREFACE

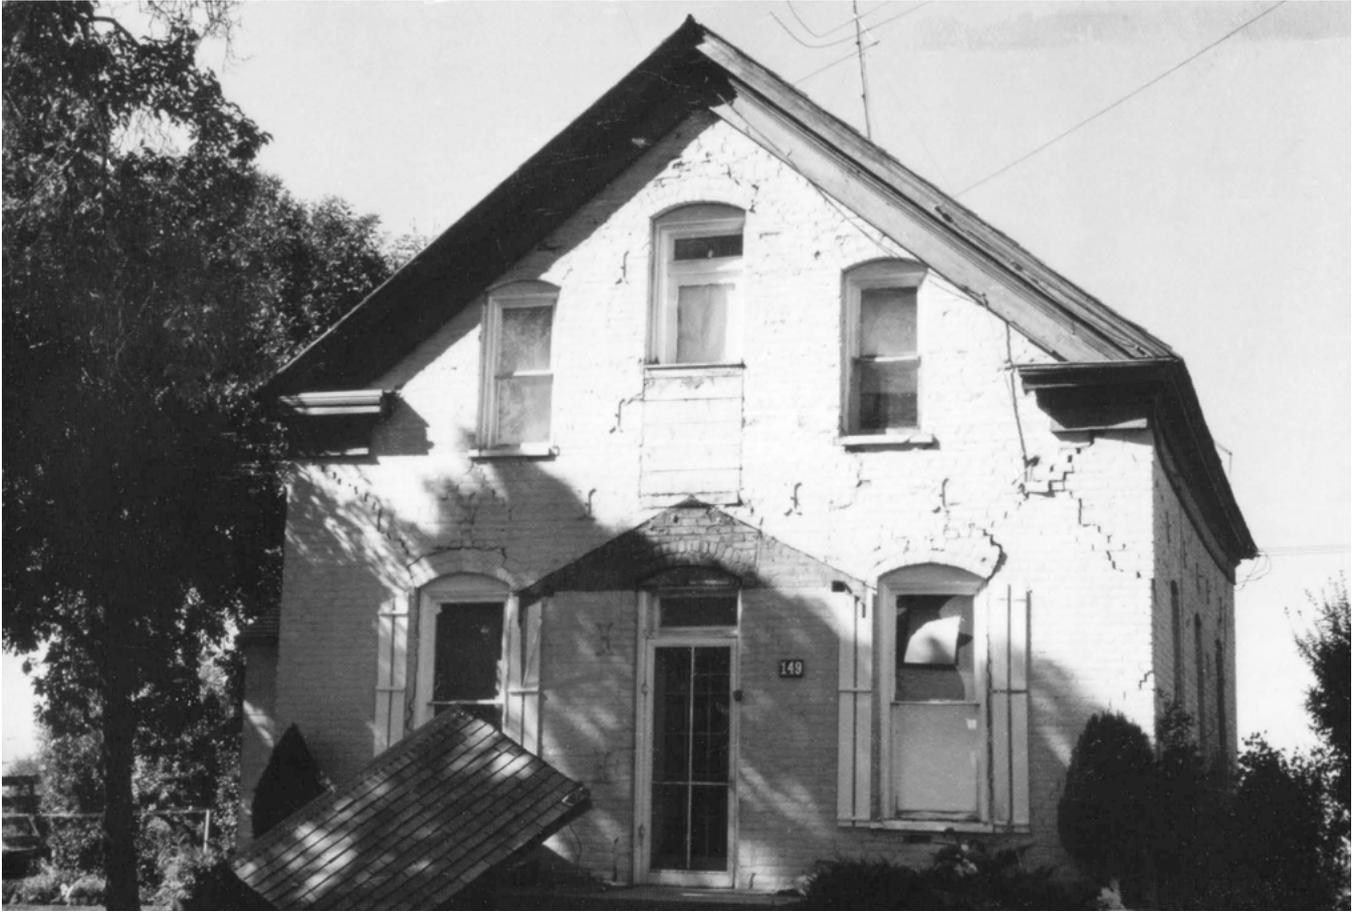
Figure 2. Cracks and failure of a Richmond, Utah, home from the 1962 magnitude 5.7 Cache Valley earthquake. The damage was extensive enough that this house was torn down. Photo: Ariel Benson.

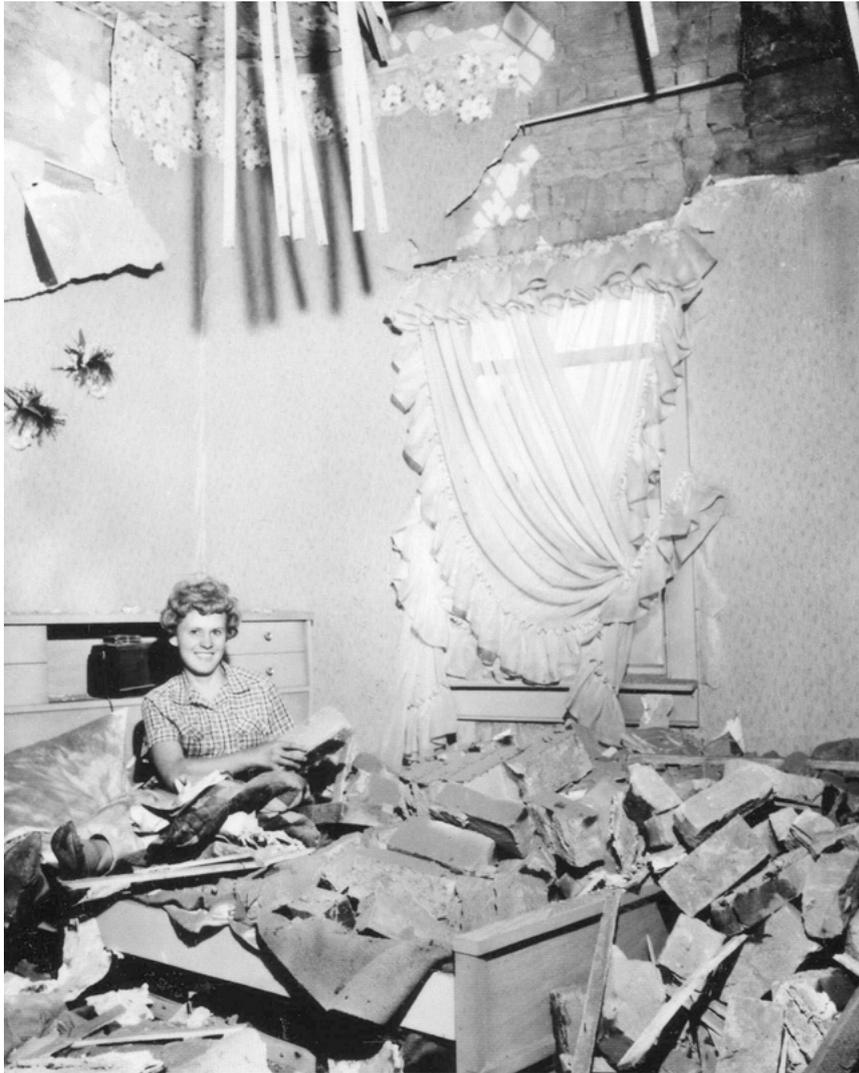
Figure 4. This young woman was in bed during the 1962 magnitude 5.7 Cache Valley, Utah, earthquake when the interior URM wall collapsed. Photo: Ariel Benson

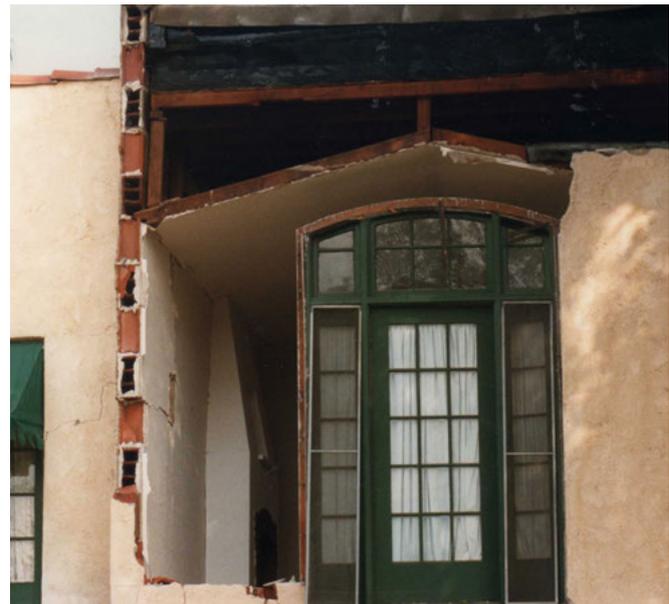
Figure 5. URM wall (hollow clay units) collapse due to earthquake.

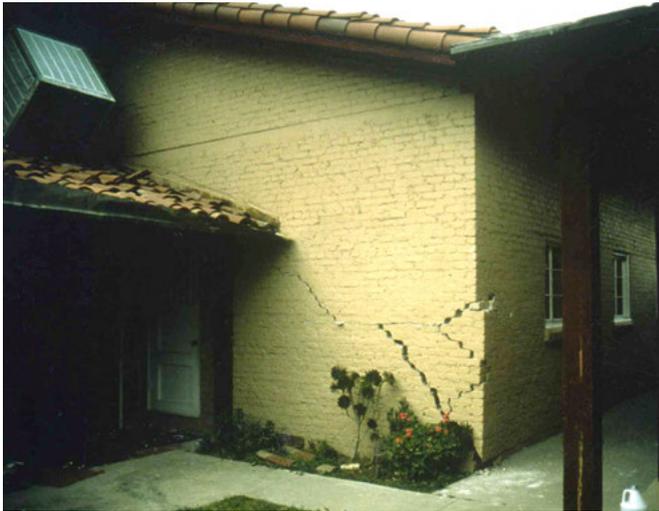
Figure 7. Earthquake damage to an URM wall and displacement of mechanical equipment on roof.

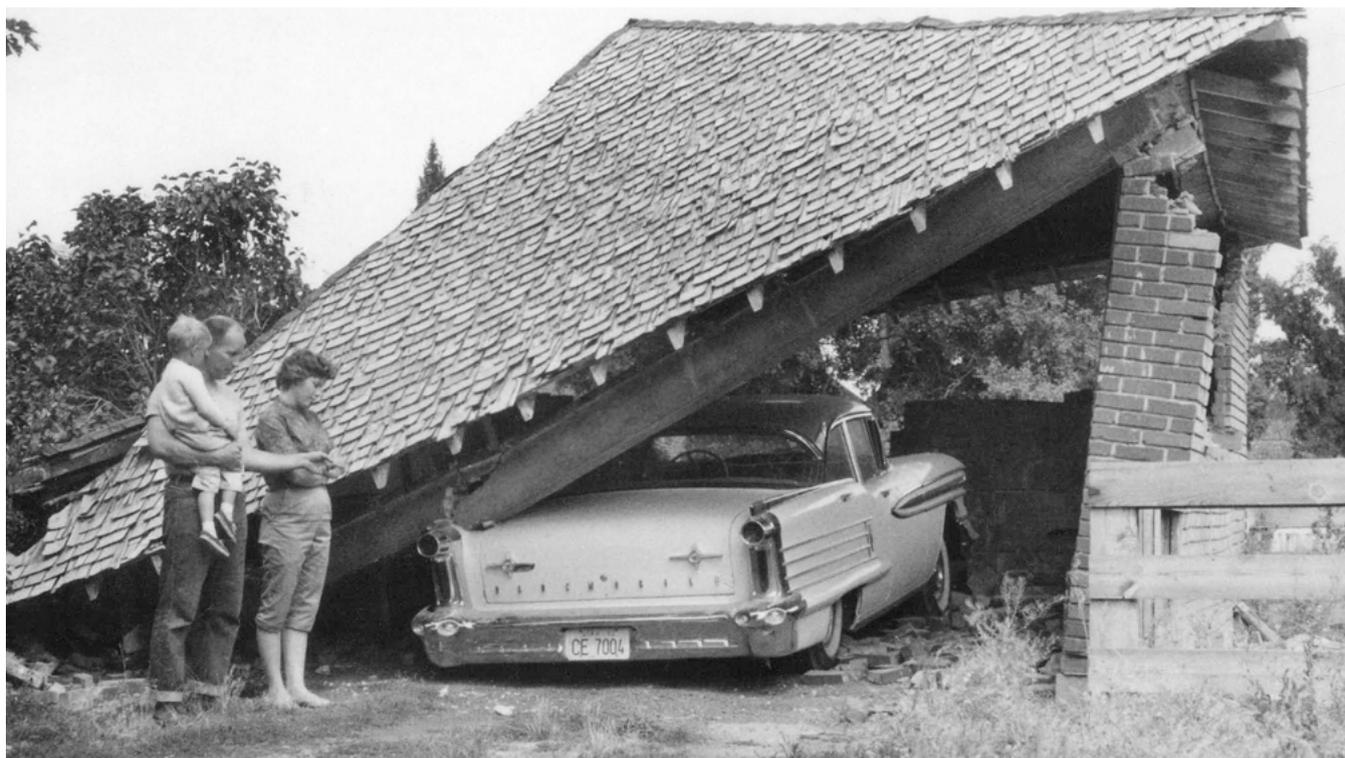
Figure 9. URM pier failure of a brick garage in Richmond, Utah, from the 1962 magnitude 5.7 Cache Valley earthquake. Photo: Ariel Benson

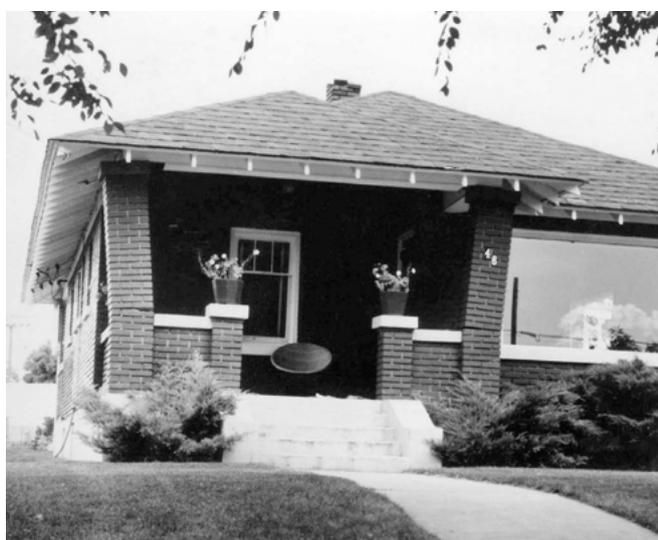
Figure 10. URM pier failure on a Richmond, Utah, house from the 1962 magnitude 5.7 Cache Valley earthquake. Photo: Ariel Benson

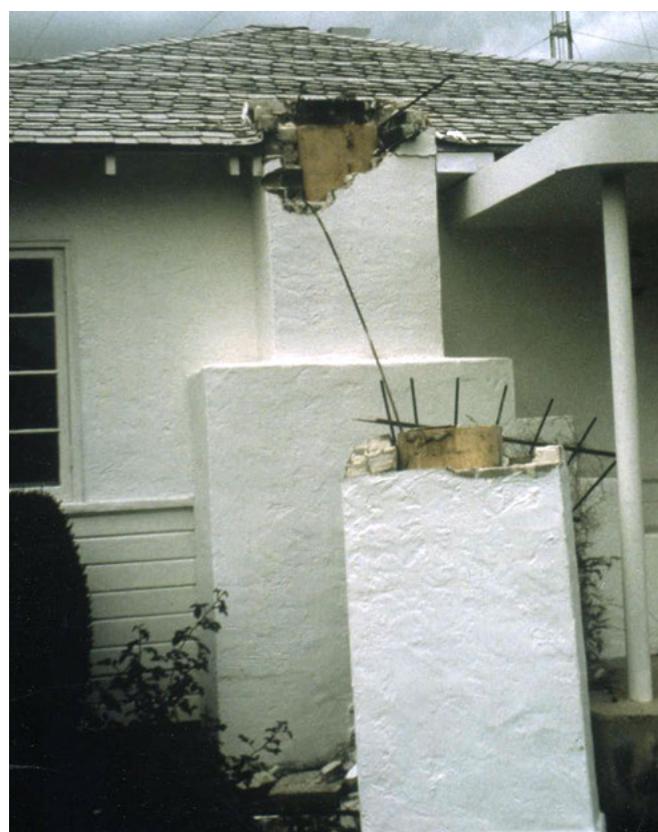
Figure 11. Chimney failure due to inadequate reinforcement.

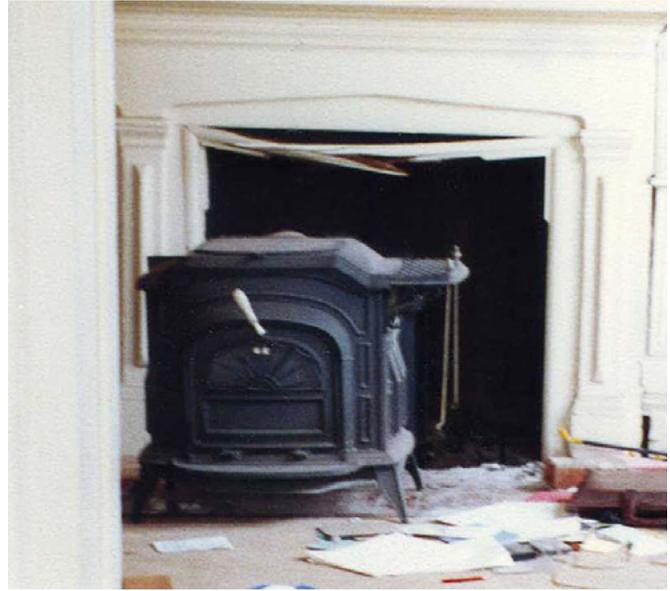
Figure 13. Displacement of wood burning stove.

Chapter 7 includes general details for upgrading (bracing, anchoring, etc.) non-structural seismic hazards. These are typically elements and dwelling contents that are not part of or are not anchored to the dwelling structure (figure 13).

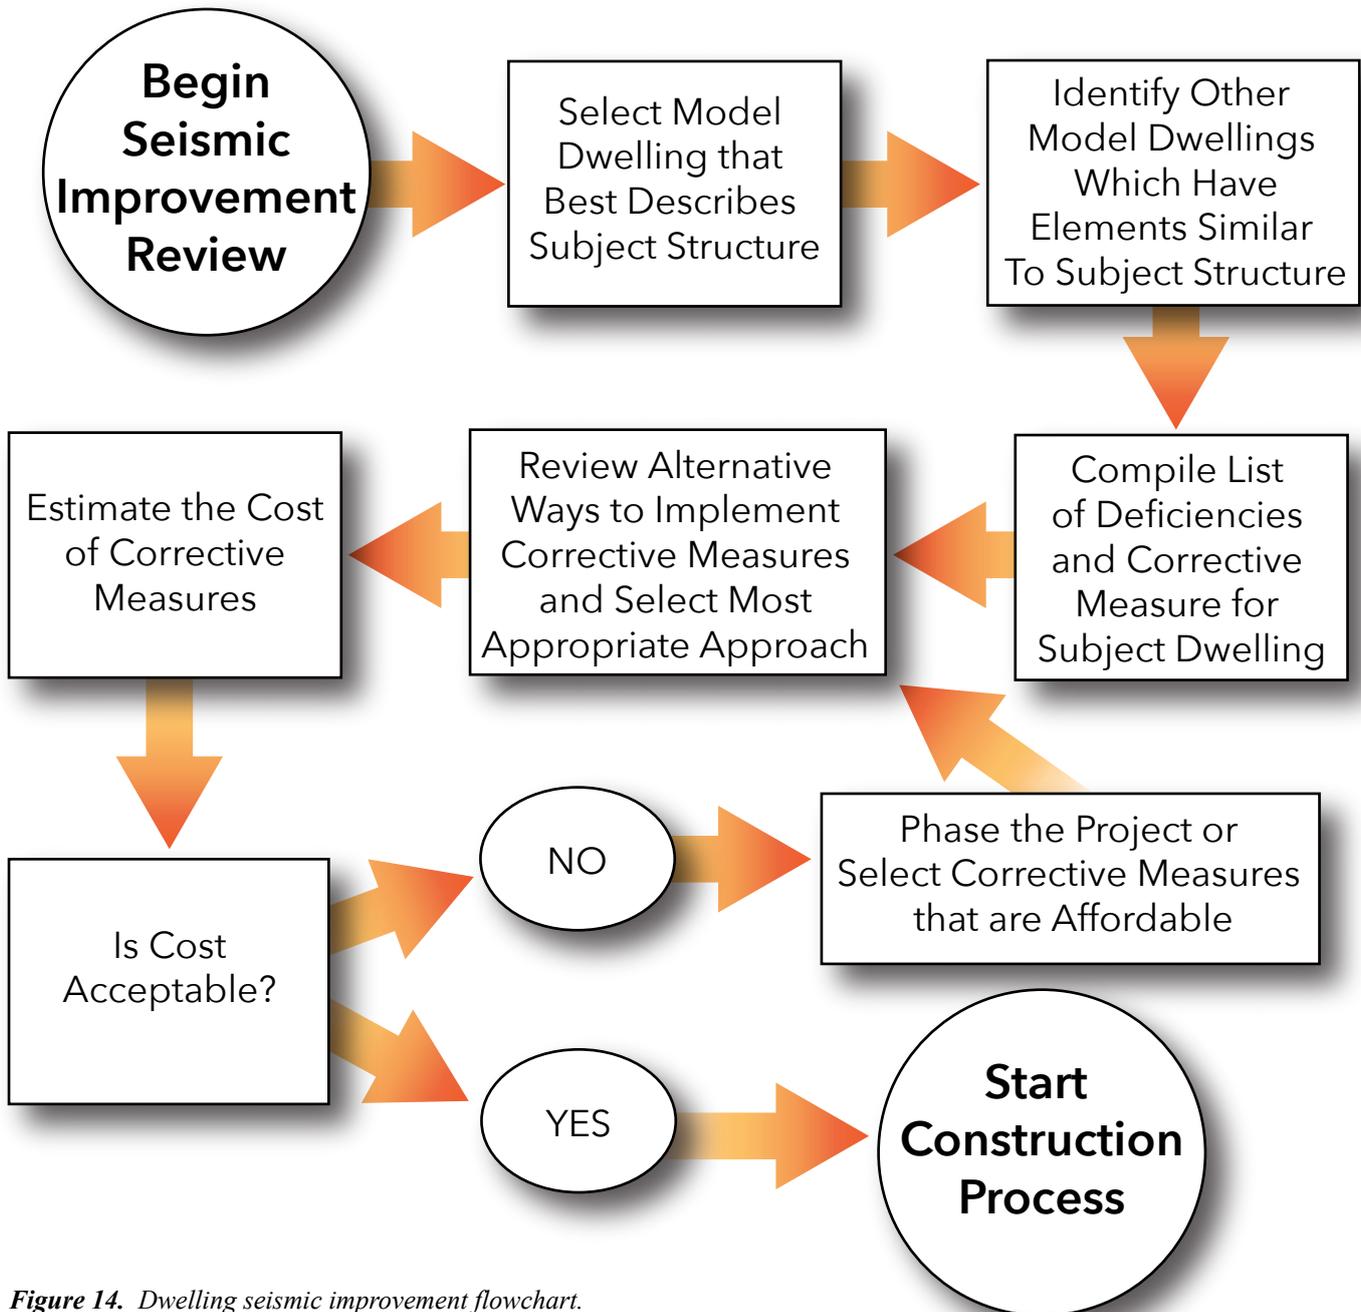
Figure 14. Dwelling seismic improvement flowchart.

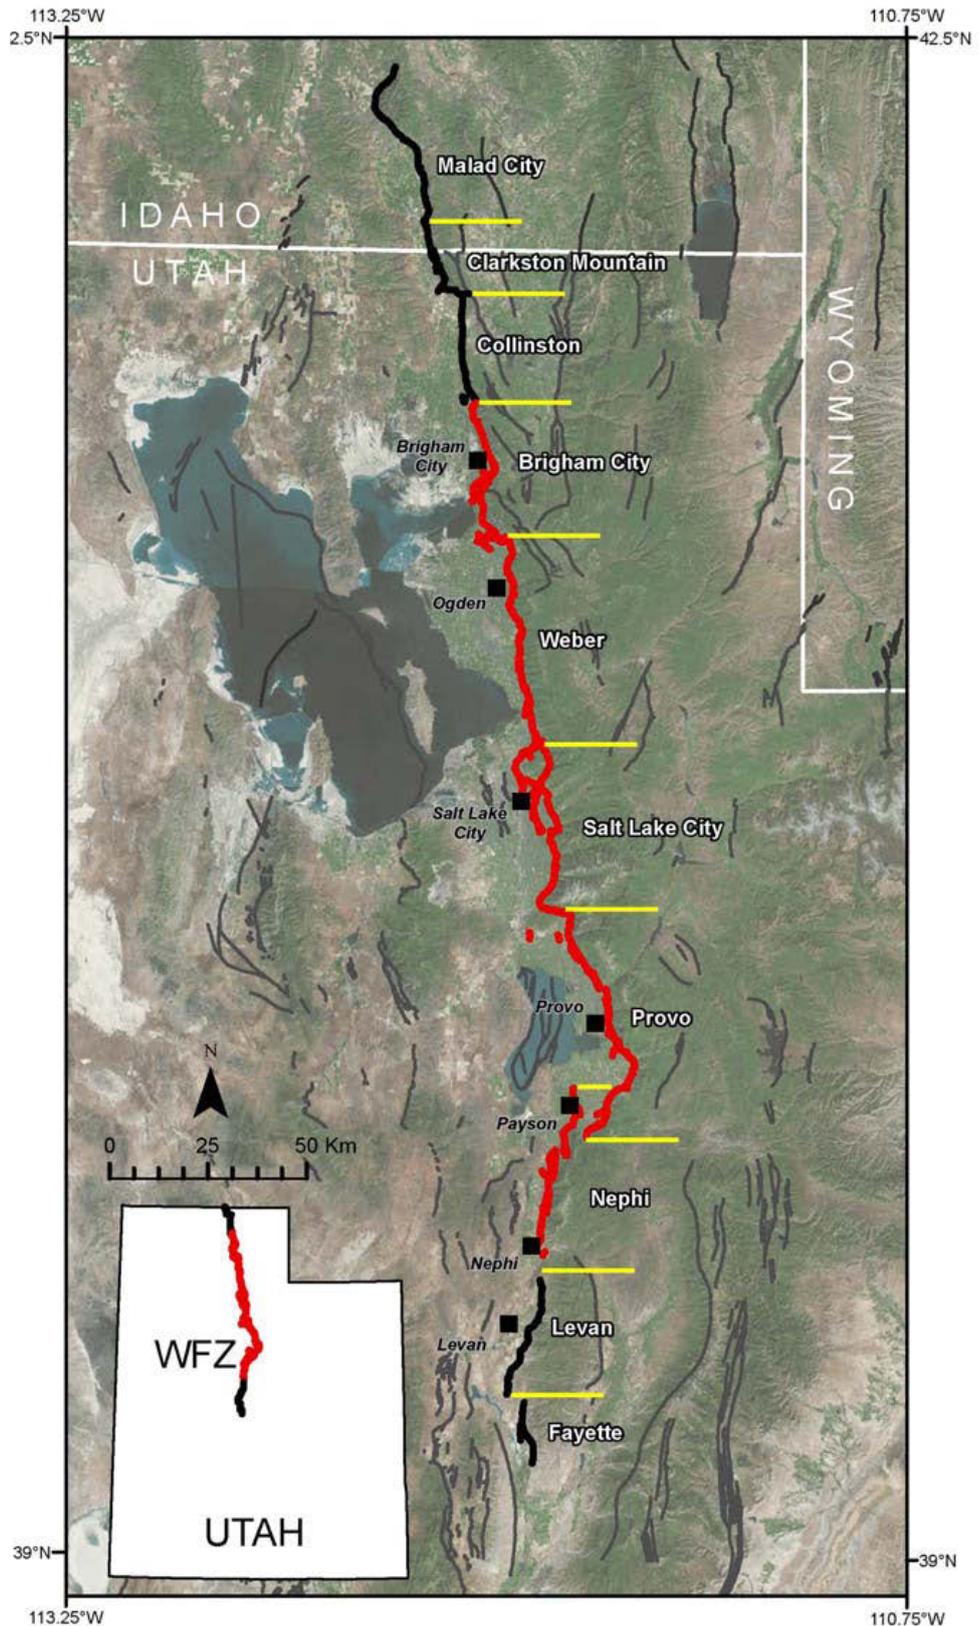
Figure 16. Segments of the Wasatch fault zone (WFZ) in northern Utah and southern Idaho. The central WFZ is shown in red, end segments of the WFZ are shown in black, and other Quaternary faults are shown in dark gray. From Wong and others, 2016.

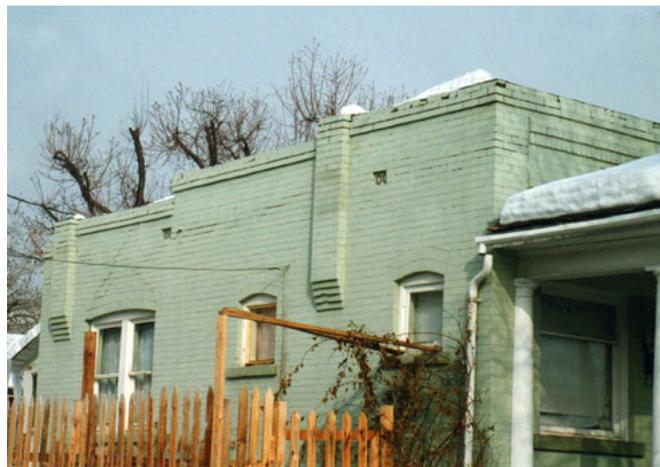
Figure 39. URM parapet walls.

A parapet is the portion of a wall that projects above the roofline and the top of a typical parapet is usually not braced (figure 39). When an earthquake occurs, the parapet can break off near the roofline from seismic forces. The bottom of the parapet near the roofline is normally weak zone because roof joists and other framing members are pocketed into the wall at this location. Failure of parapets can create a falling hazard that is a serious life safety concern, especially over doorways and walkways. As a general rule, the higher the parapet, the more serious the

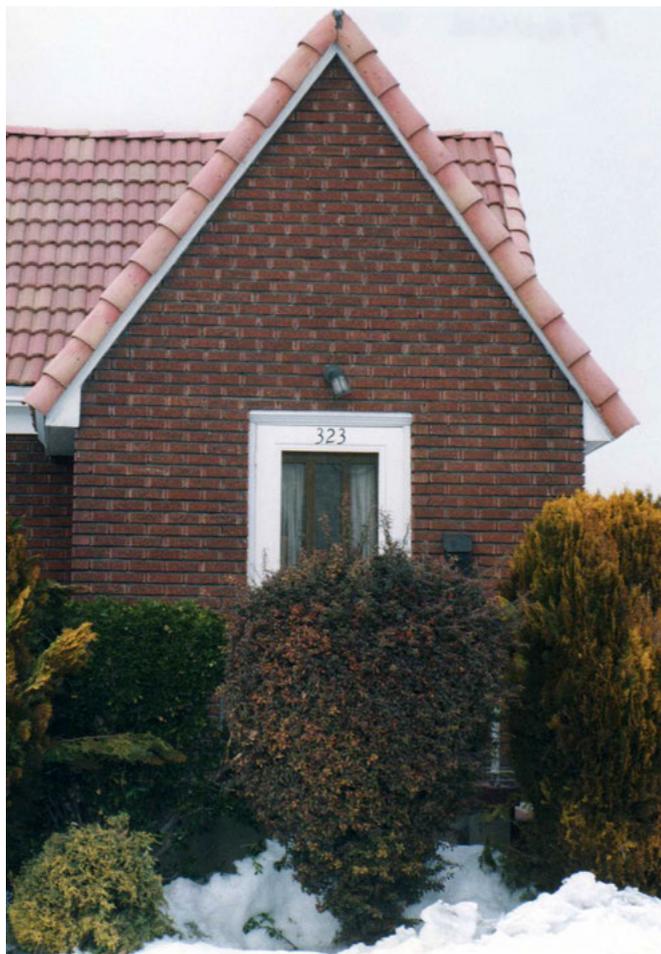
Figure 40. URM gable end walls.

A gable end wall is the triangle section of an exterior wall under the roof plane and above the eaves line (figure 40). This portion of a typical URM wall is not normally braced and supports the roof ridge. The height of this wall and the unbraced condition make it less stable than other elements to resist out-of-plane forces. Out-of-plane failure of a gable end wall is similar to that described for URM walls. The size of the gable end wall and the intensity and direction of seismic forces will have a direct effect on the stability of the wall. A wide gable generally supports a large portion of the roof. Failure of this type of gable end wall is likely to also result in at least partial collapse of the roof. The roof

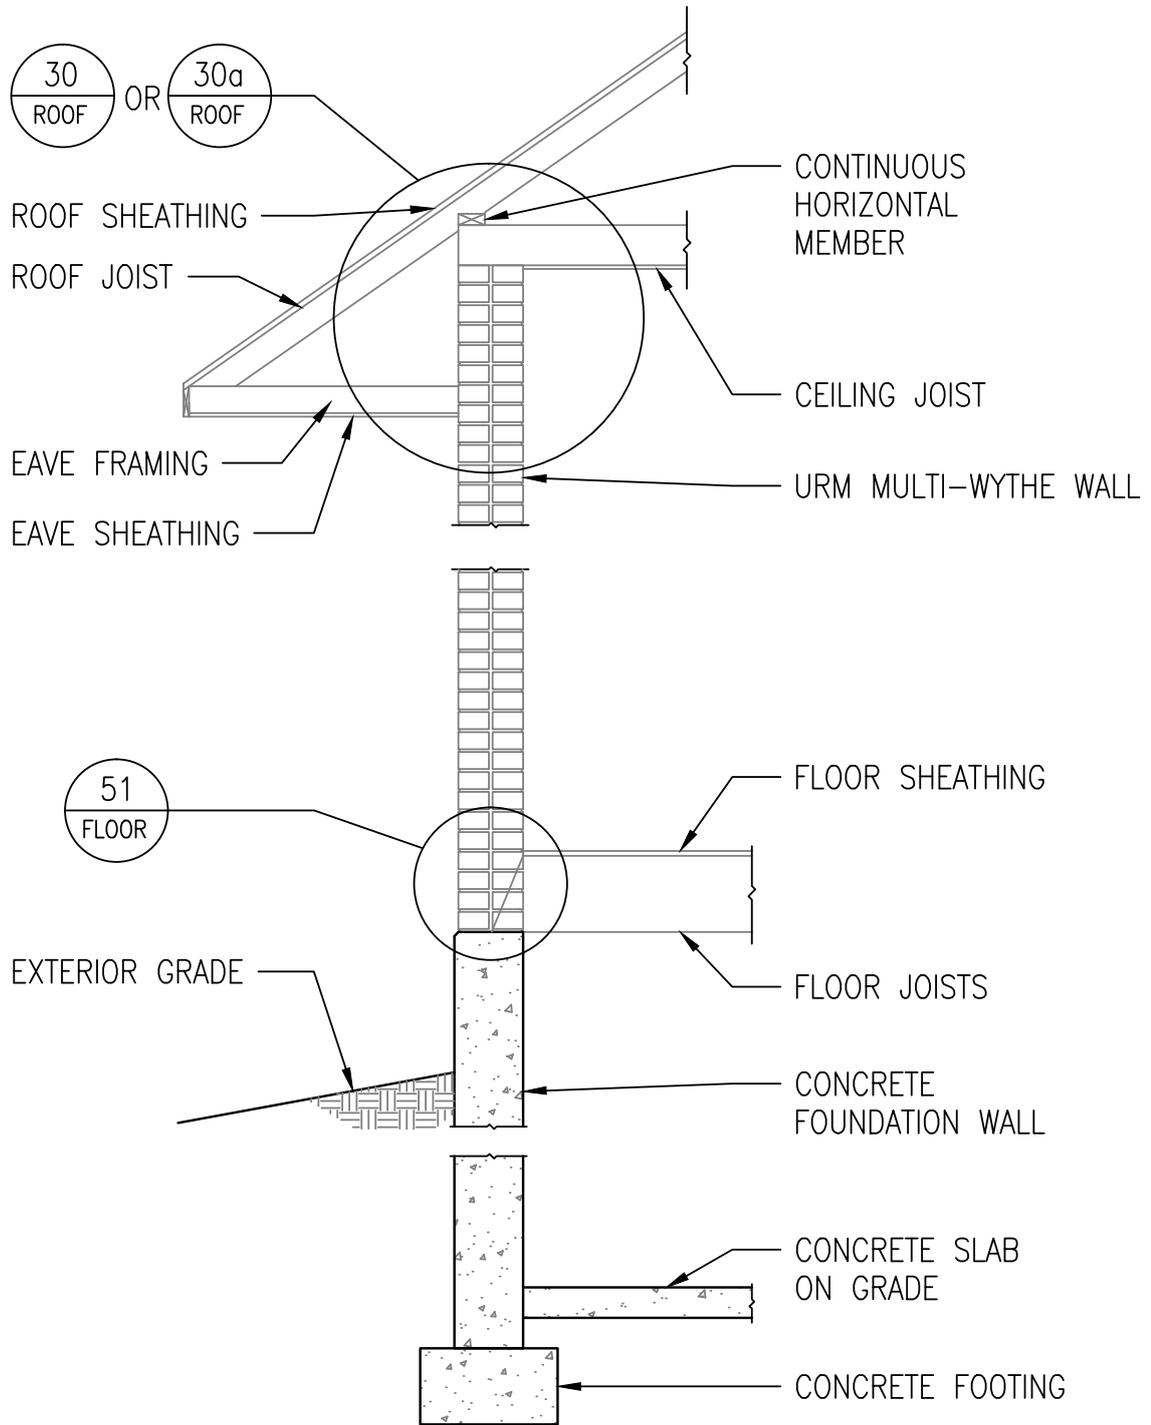
Single story, double wythe brick with basement

1 SECTION W/ JOIST FRAMING PERPENDICULAR TO WALL

Details 1 and 2 show two different existing exterior wall details for a Model A dwelling. Reference circles have been superimposed onto these details showing the area of the wall where seismic deficiencies normally occur. The details for improvements to strengthen these deficiencies are found in Chapter 6. Table 1 and the additional details in Chapters 6 and 7 also recommend other improvements, although not illustrated in these exterior wall details.

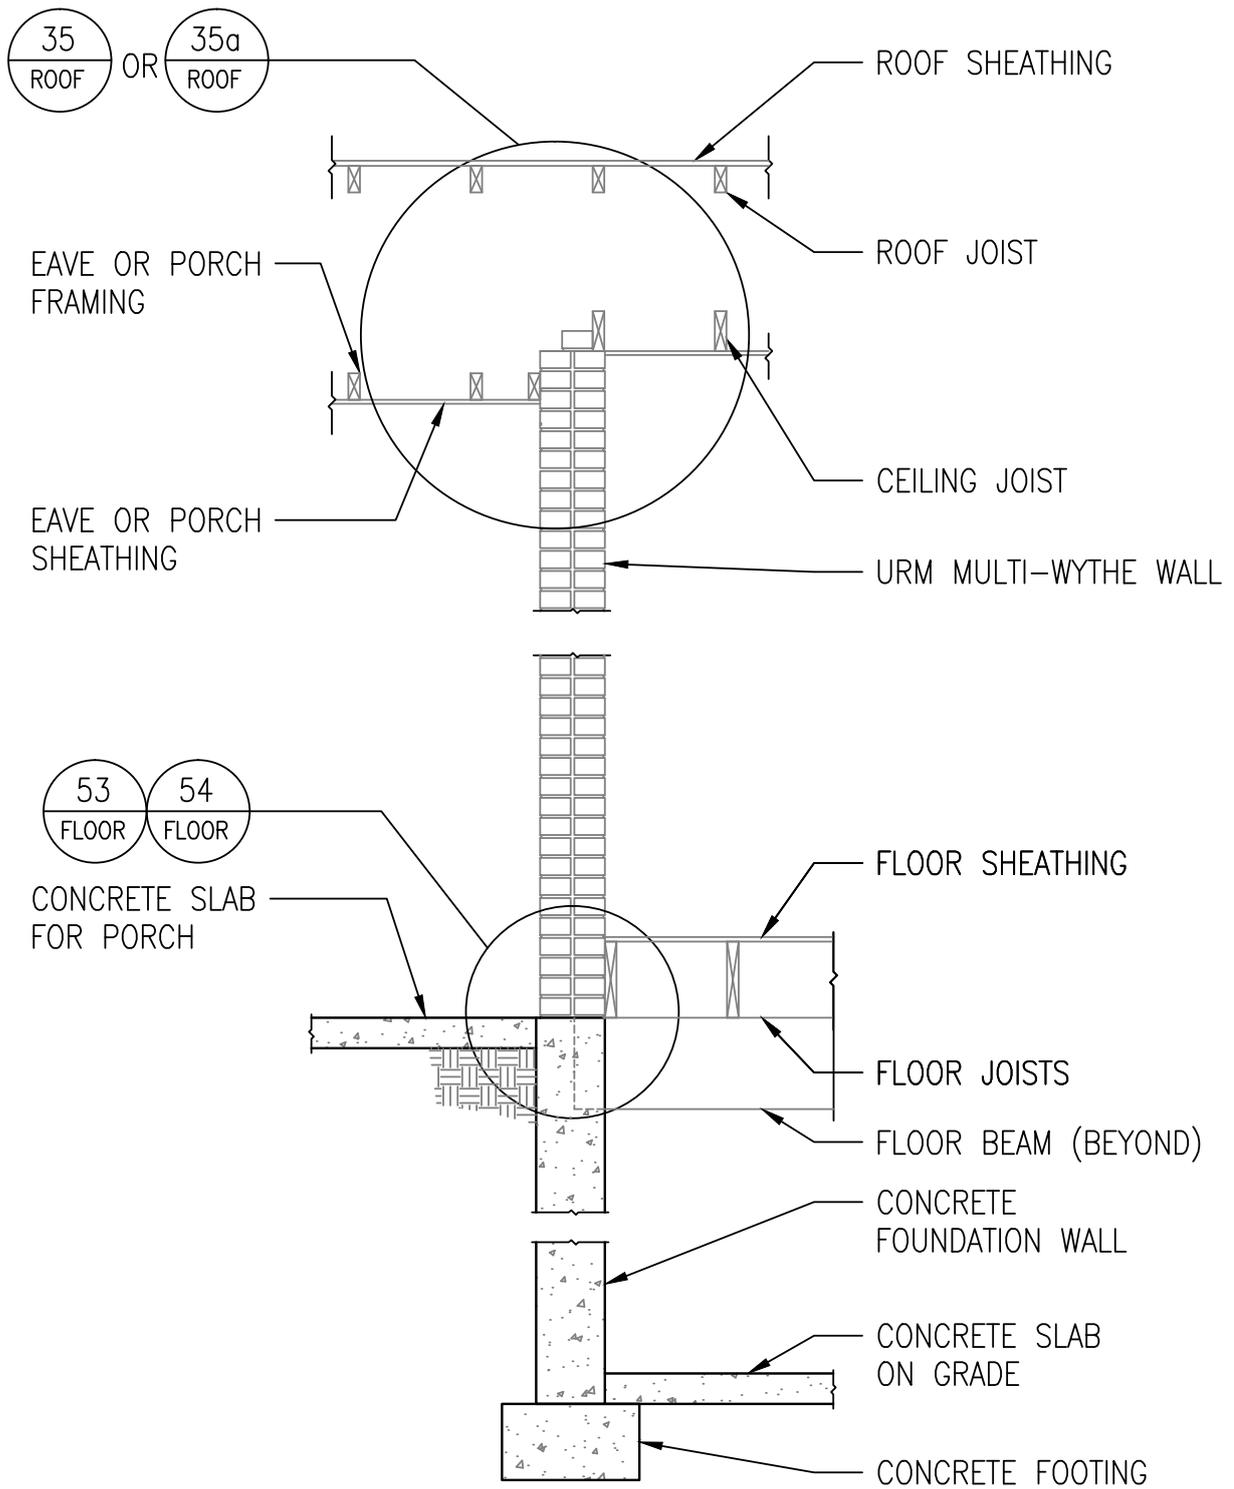
2 SECTION W/ JOIST FRAMING
SECTION PARALLEL TO WALL

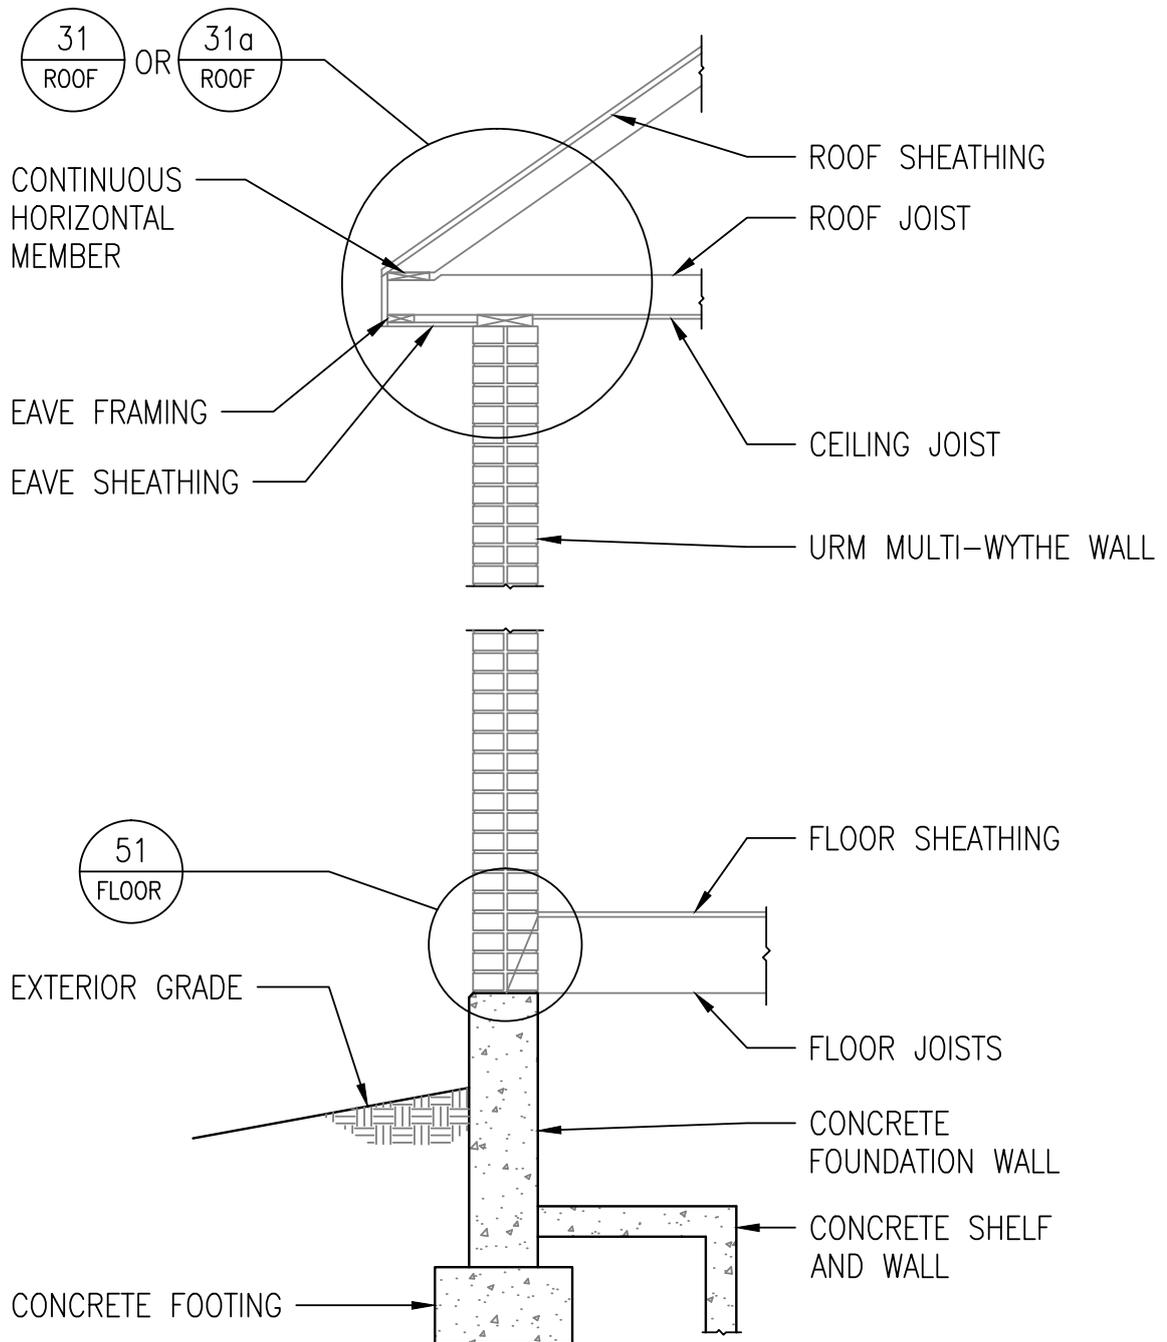
Single story double wythe brick with shelf basement and attic

3 SECTION W/ JOIST FRAMING PERPENDICULAR TO WALL

Details 3 and 4 show two different existing wall details for Model B. Reference circles have been superimposed onto these details showing the area of the wall where seismic deficiencies normally occur. The details for improvements to strengthen these deficiencies are found in Chapter 6. Table 1 and the additional details in Chapters 6 and 7 also recommend other improvements, although not illustrated in these exterior wall details.

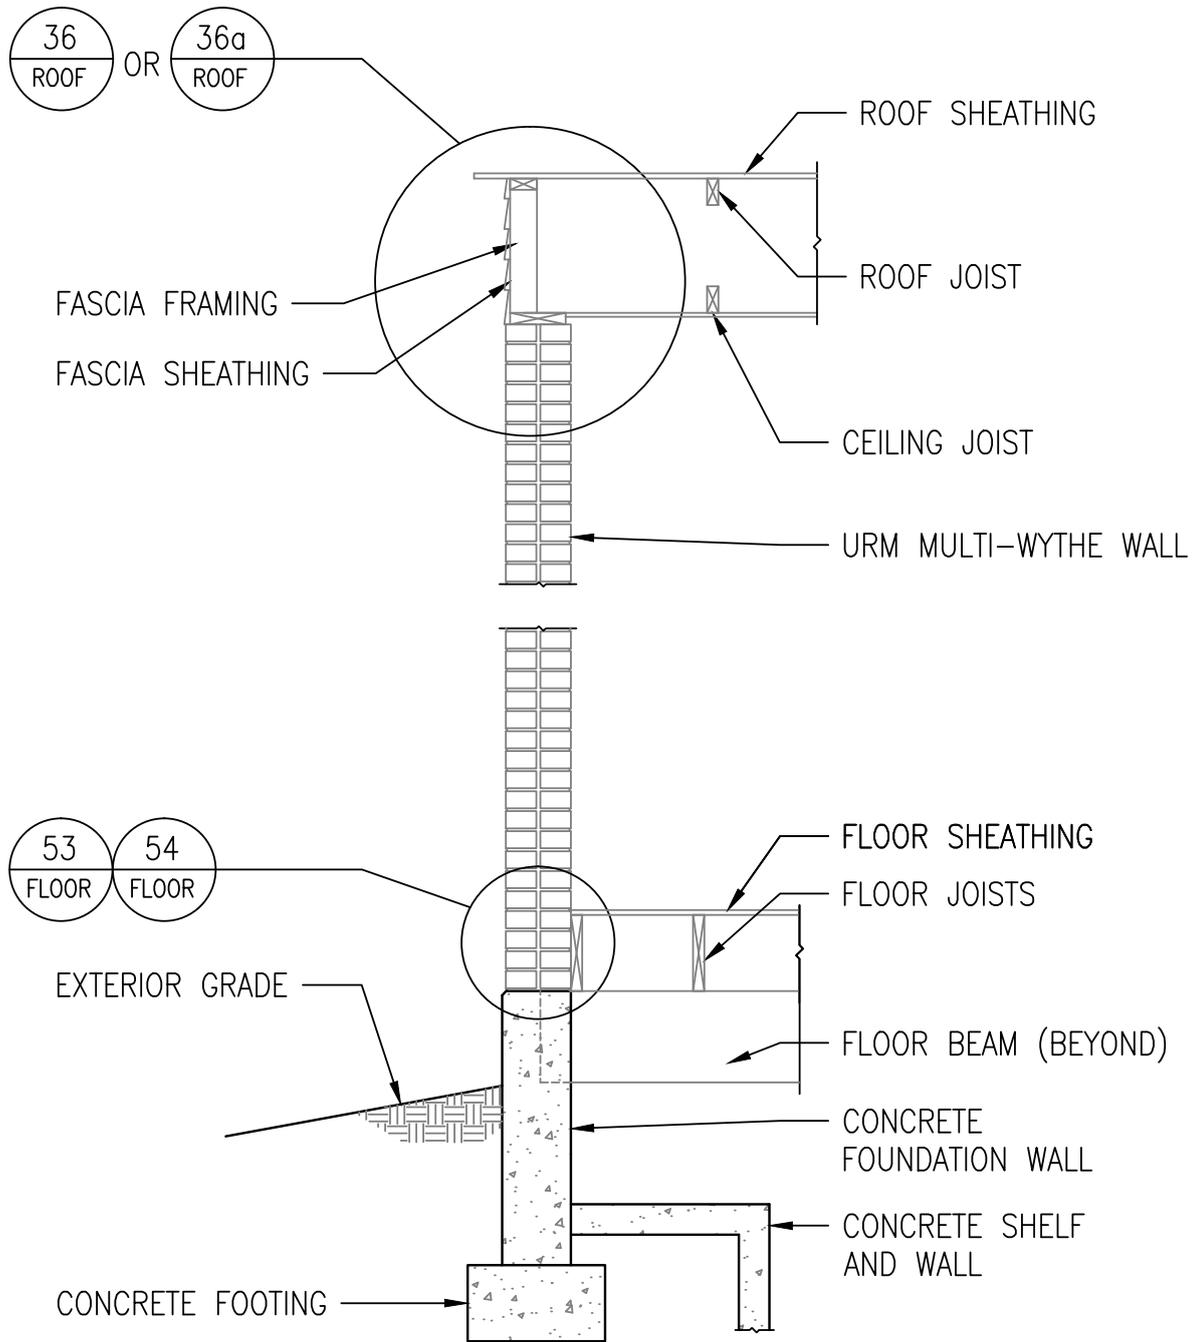
4 SECTION W/ JOIST FRAMING PARALLEL TO WALL

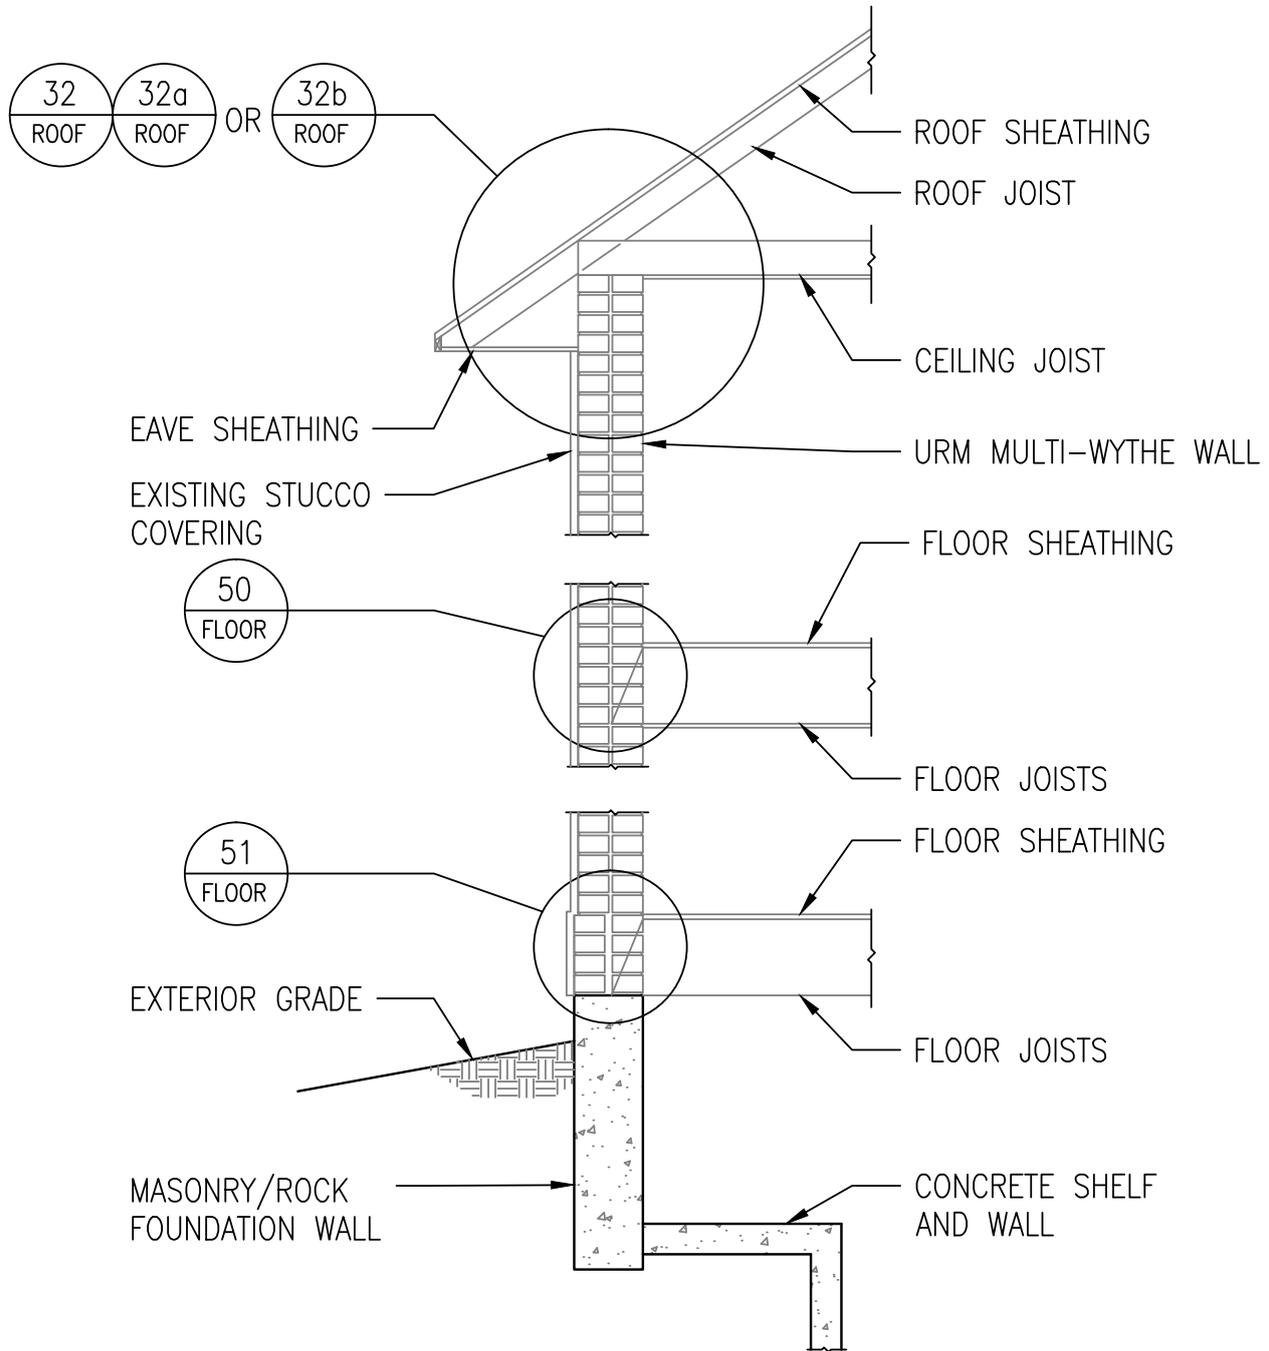
Two story, stucco-covered, double wythe brick with shelf basement and attic

5 SECTION W/ JOIST FRAMING PERPENDICULAR TO WALL

Details 5 and 6 show two different existing exterior walls sections for Model C. Reference circles have been superimposed onto the details showing the area of the wall where seismic deficiencies normally occur. The details for improvements to strengthen these deficiencies are found in Chapter 6. Table 1 and the additional details in Chapters 6 and 7 also recommend other improvements, although not illustrated in these exterior wall details.

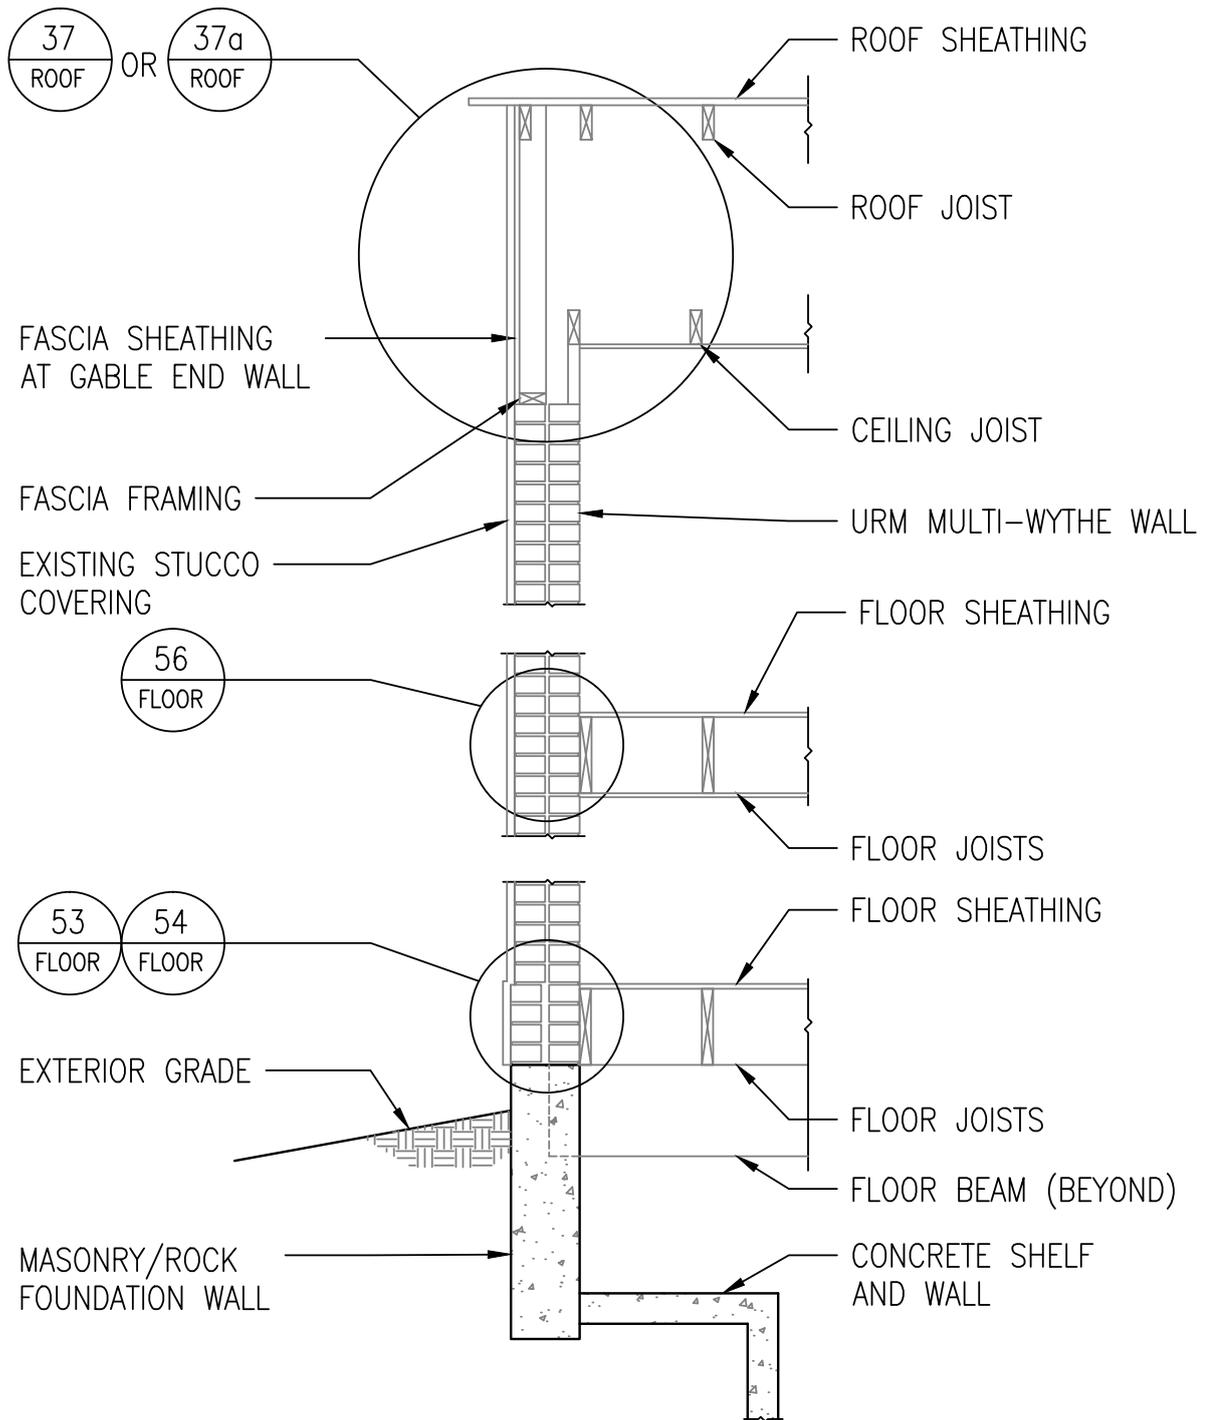
6 SECTION W/ JOIST FRAMING PARALLEL TO WALL

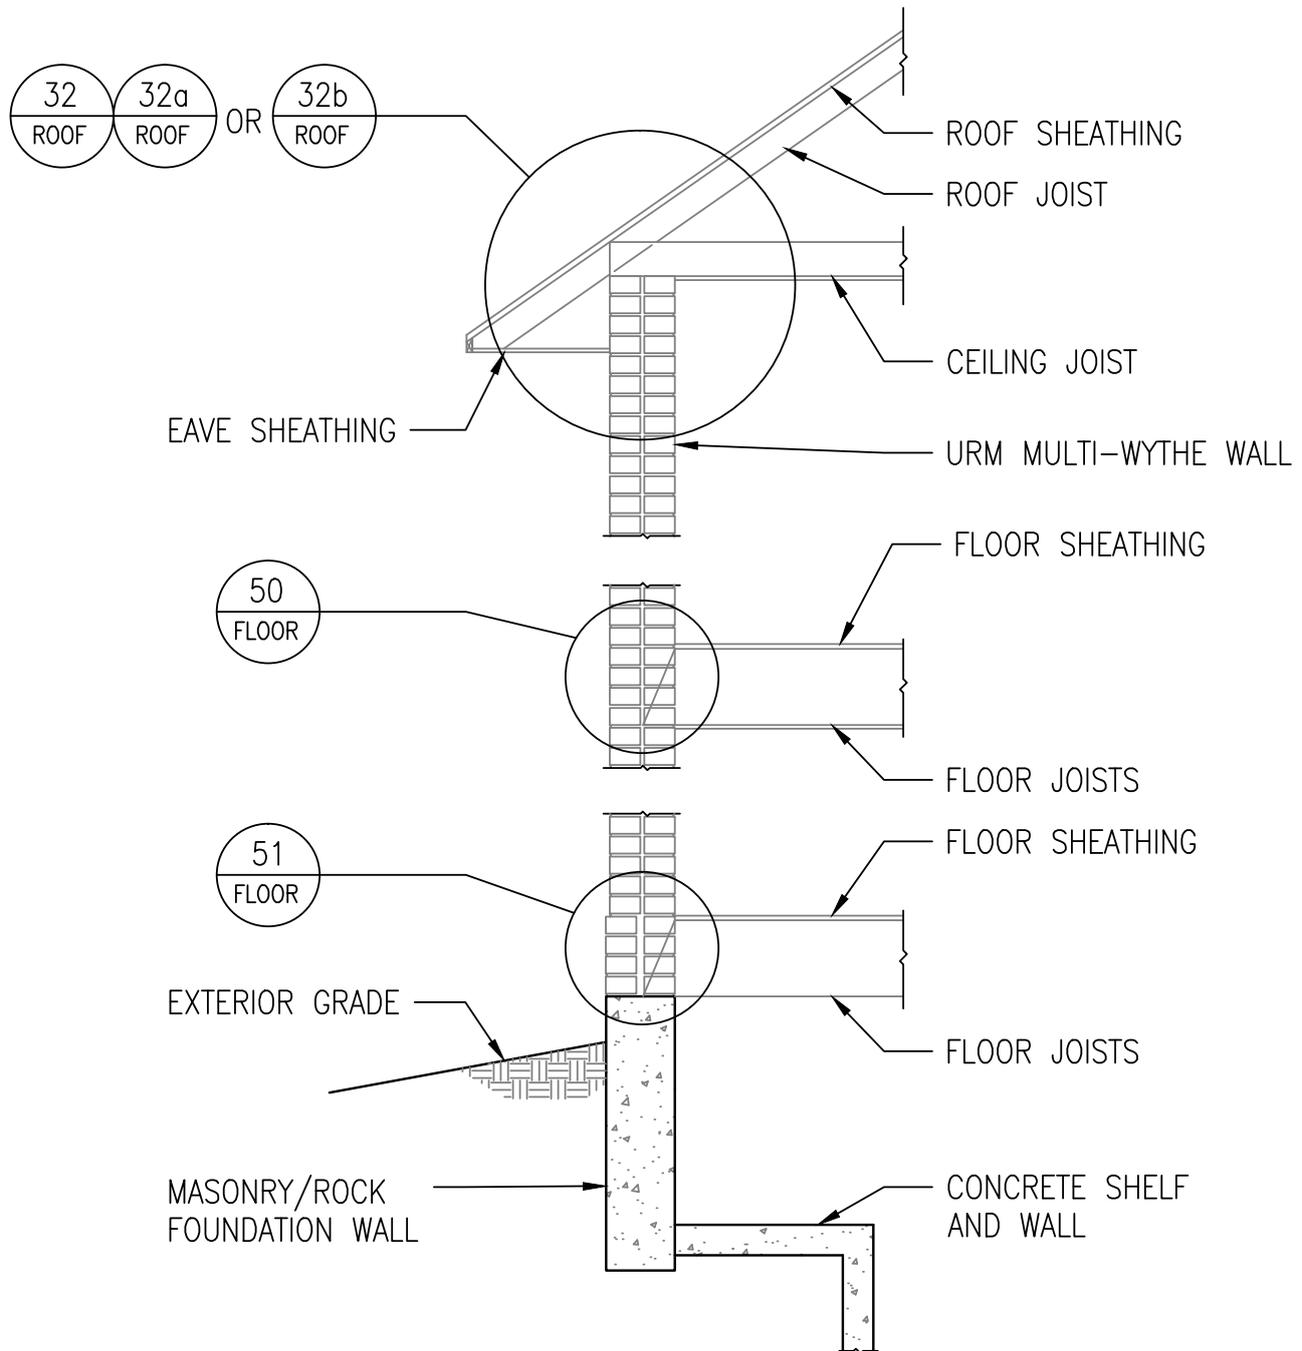
Two story, stucco-covered, double wythe brick with shelf basement and attic

7 SECTION W/ JOIST FRAMING PERPENDICULAR TO WALL

Details 7 and 8 show two different existing exterior wall sections for Model D. Reference circles have been superimposed into these details showing the area of the wall where seismic deficiencies normally occur. The details for improvements to strengthen these deficiencies are found in Chapter 6. Table 1 and the additional details in Chapters 6 and 7 also recommend other improvements, although not illustrated in these exterior wall details.
