THE UTAH GUIDE FOR THE SEISMIC IMPROVEMENT OF UNREINFORCED MASONRY DWELLINGS

**Utah Seismic Safety Commission
Existing Buildings Committee
Second Edition
2016**

PREFACE

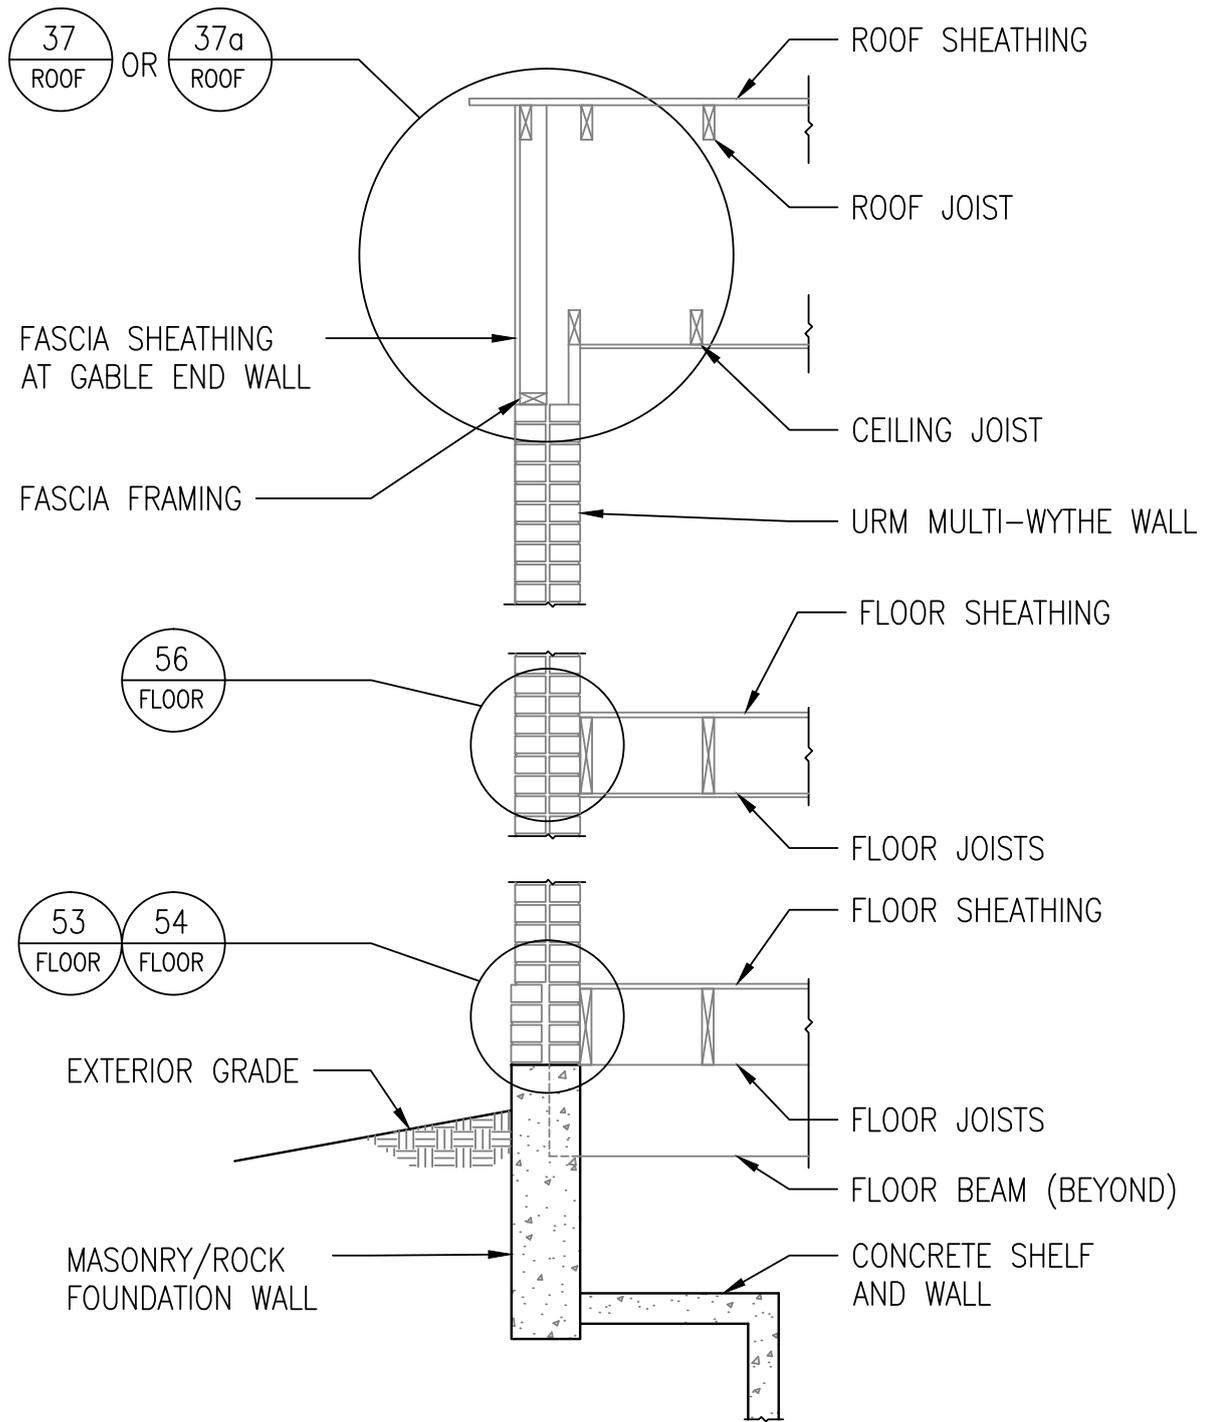
8 SECTION W/ JOIST FRAMING
PARALLEL TO WALL

Details 7 and 8 show two different existing exterior wall sections for Model D. Reference circles have been superimposed into these details showing the area of the wall where seismic deficiencies normally occur. The details for improvements to strengthen these deficiencies are found in Chapter 6. Table 1 and the additional details in Chapters 6 and 7 also recommend other improvements, although not illustrated in these exterior wall details.

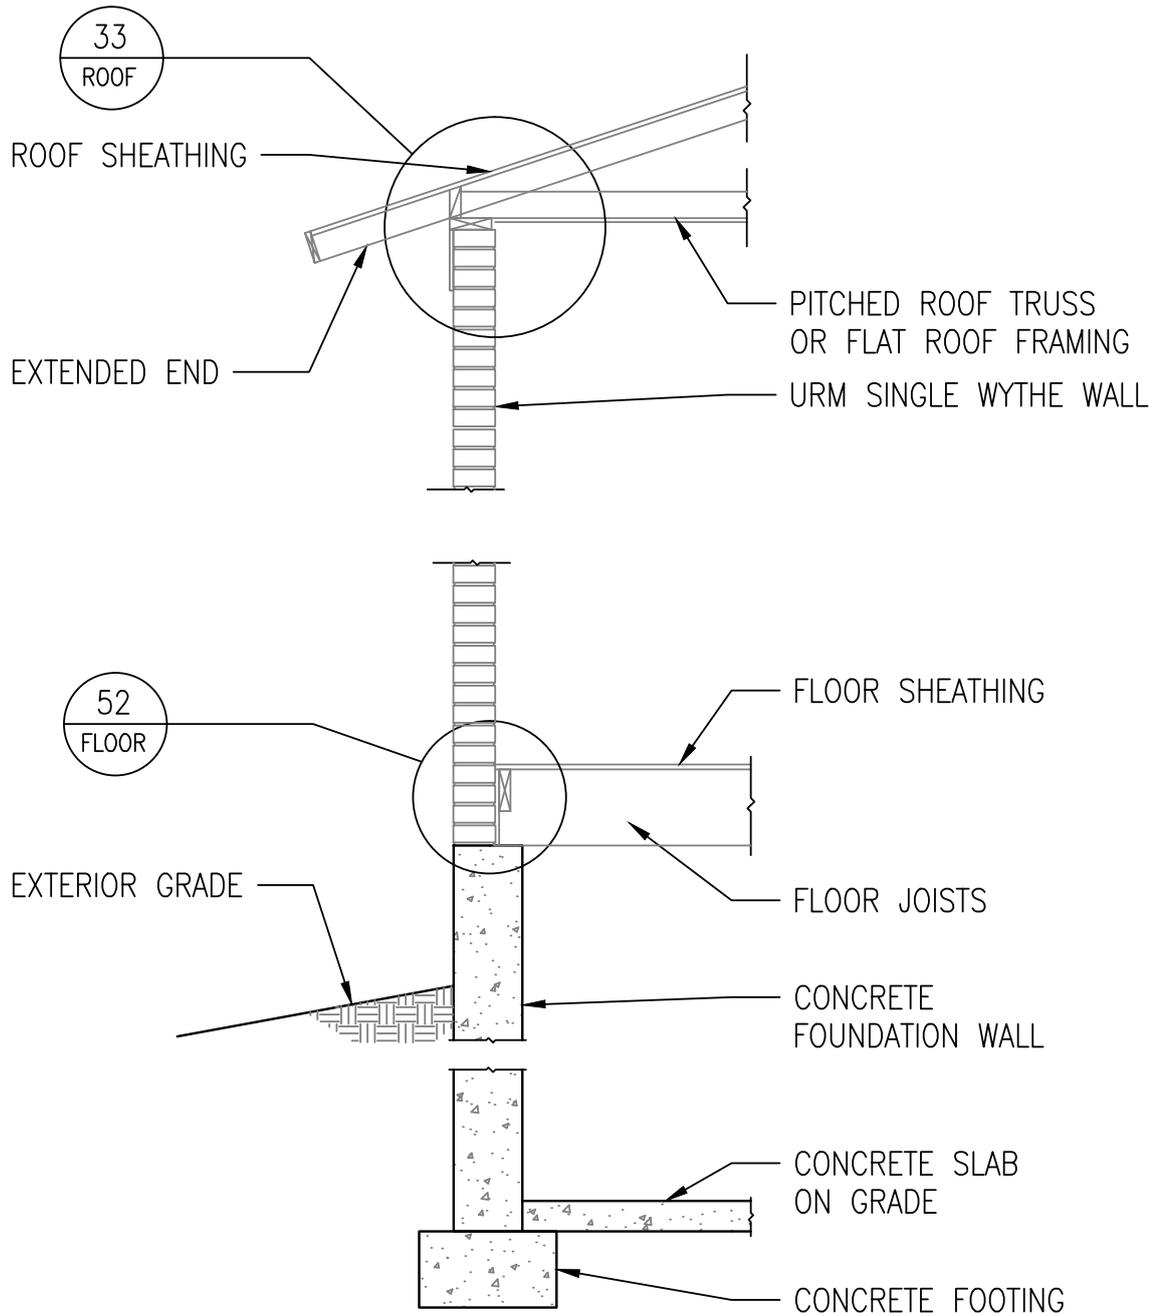
Single story, single wythe, solid brick with full basement

9 SECTION W/ JOIST FRAMING
SECTION PERPENDICULAR TO WALL

Details 9 and 10 show two different existing exterior wall sections for Model E. Reference circles have been superimposed into these details showing the area of the wall where seismic deficiencies normally occur. The details for improvements to strengthen these deficiencies are found in Chapter 6. Table 1 and the additional details in Chapters 6 and 7 also recommend other improvements, although not illustrated in these exterior wall details.

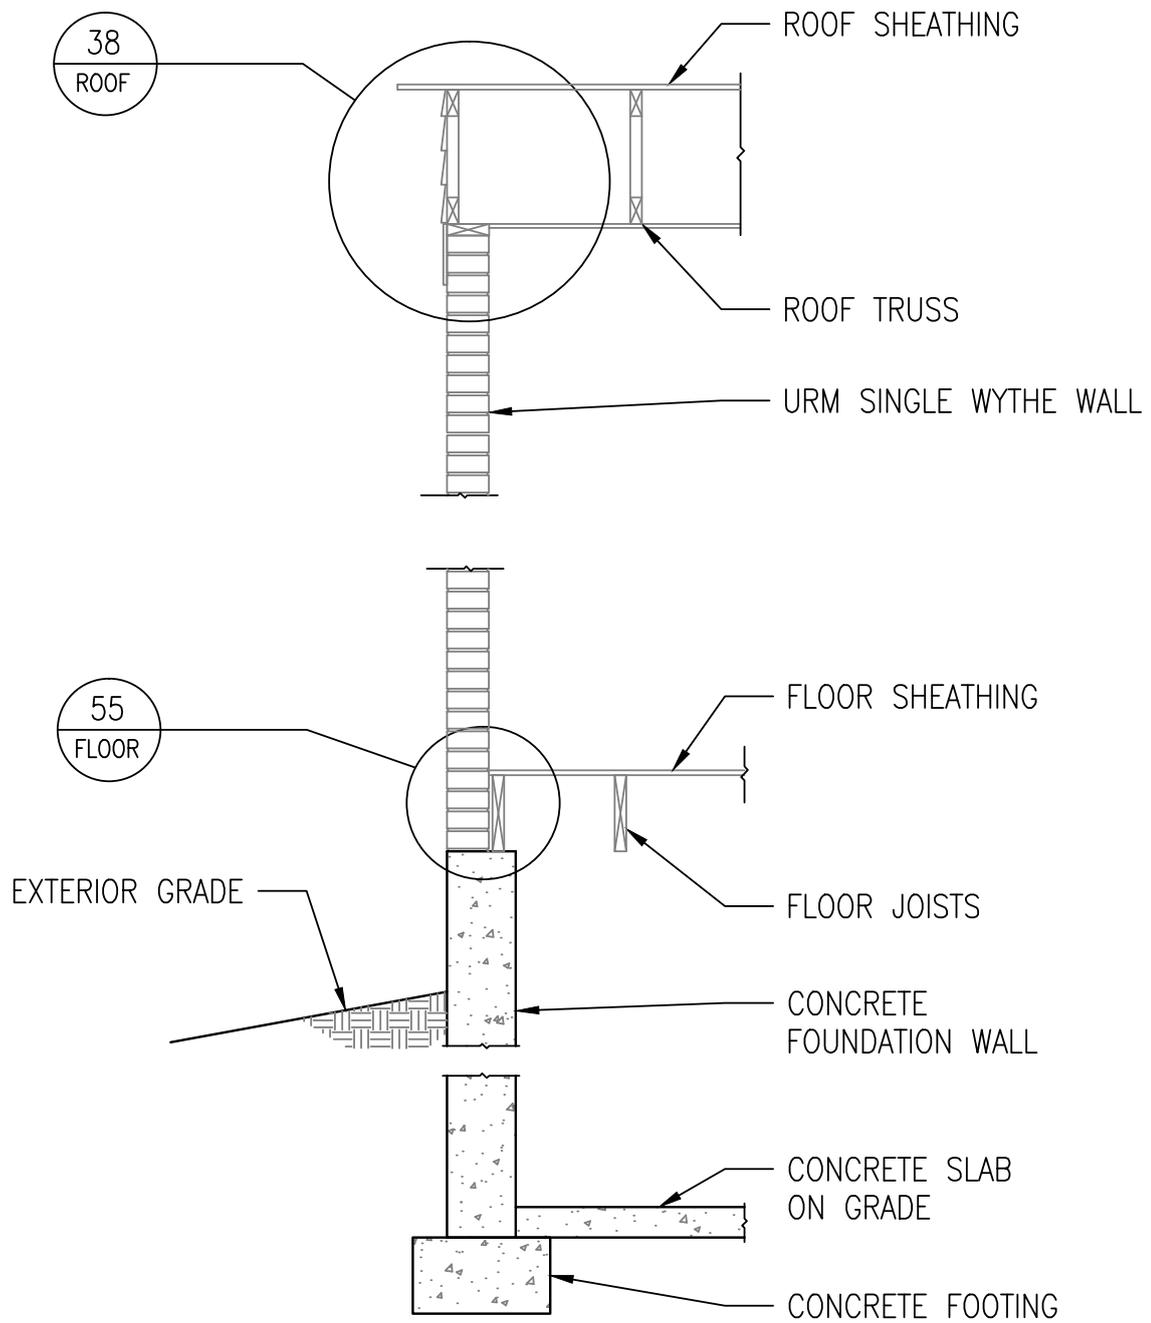
10 SECTION W/ JOIST FRAMING
PARALLEL TO WALL

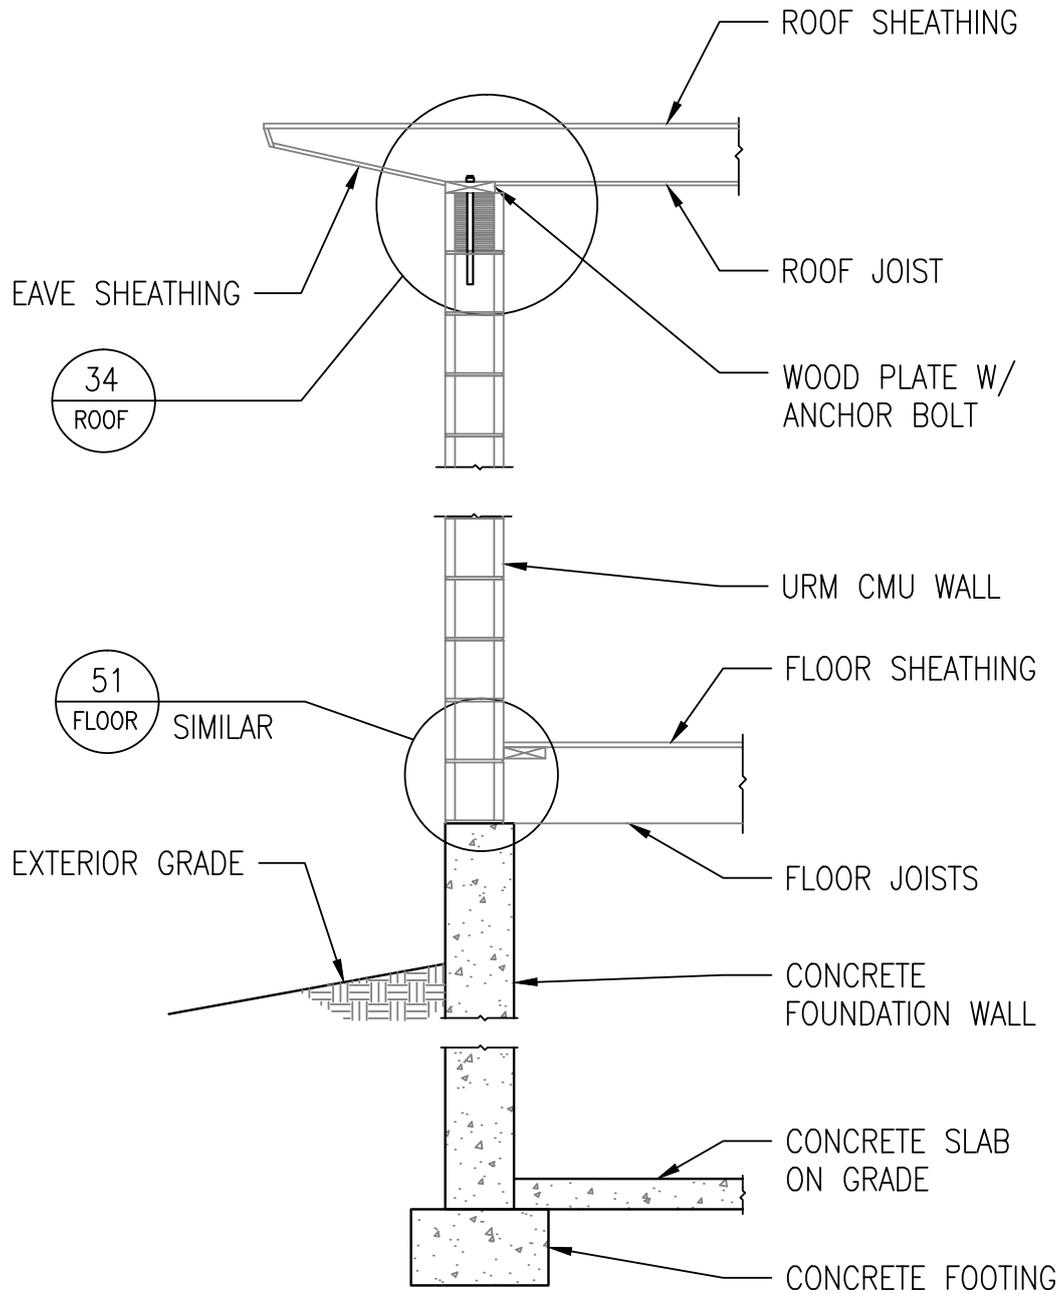
Single story concrete/cinder block (CMU) with basement and flat roof

11 SECTION W/ JOIST FRAMING PERPENDICULAR TO WALL

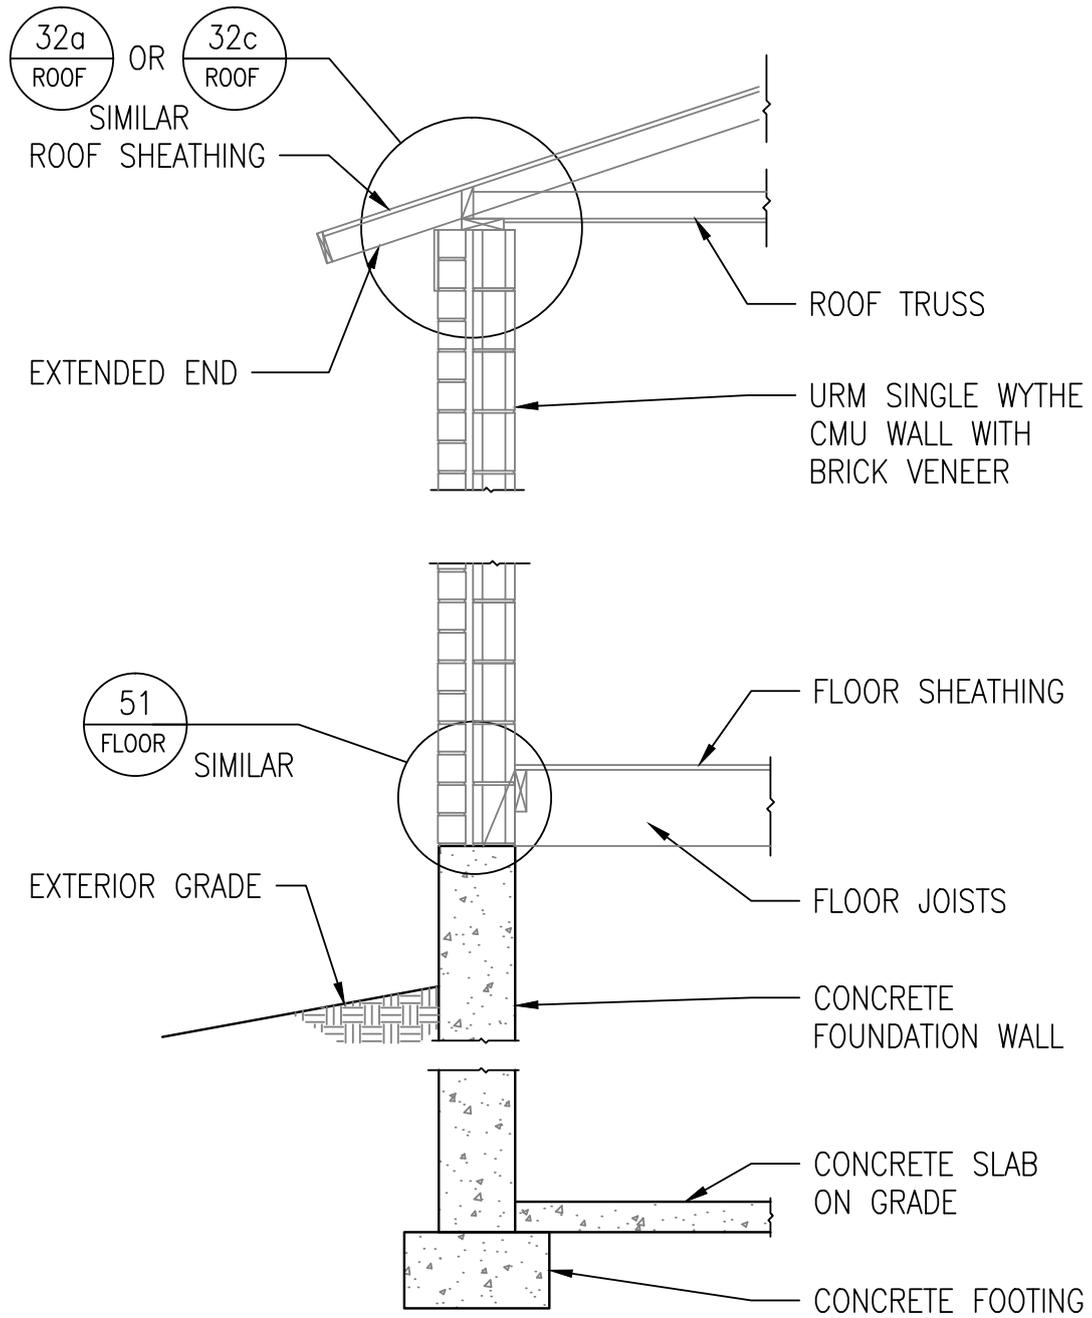
Single story concrete/cinder block (CMU) with brick veneer and full basement

12 SECTION W/ JOIST FRAMING PERPENDICULAR TO WALL

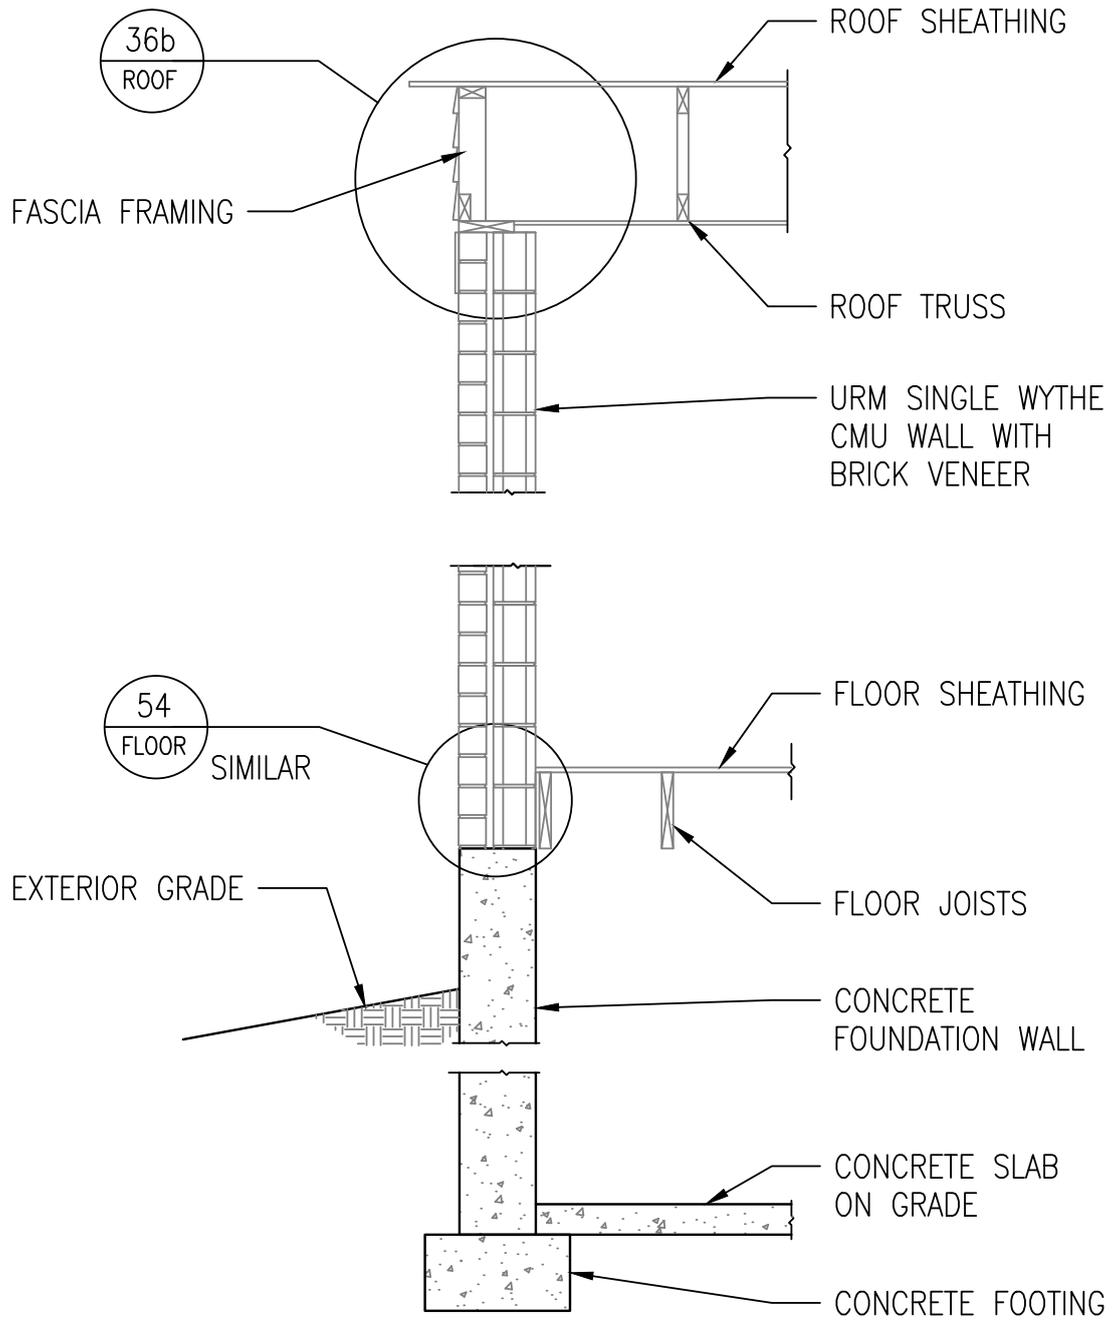
13 SECTION W/ JOIST FRAMING
PARALLEL TO WALL

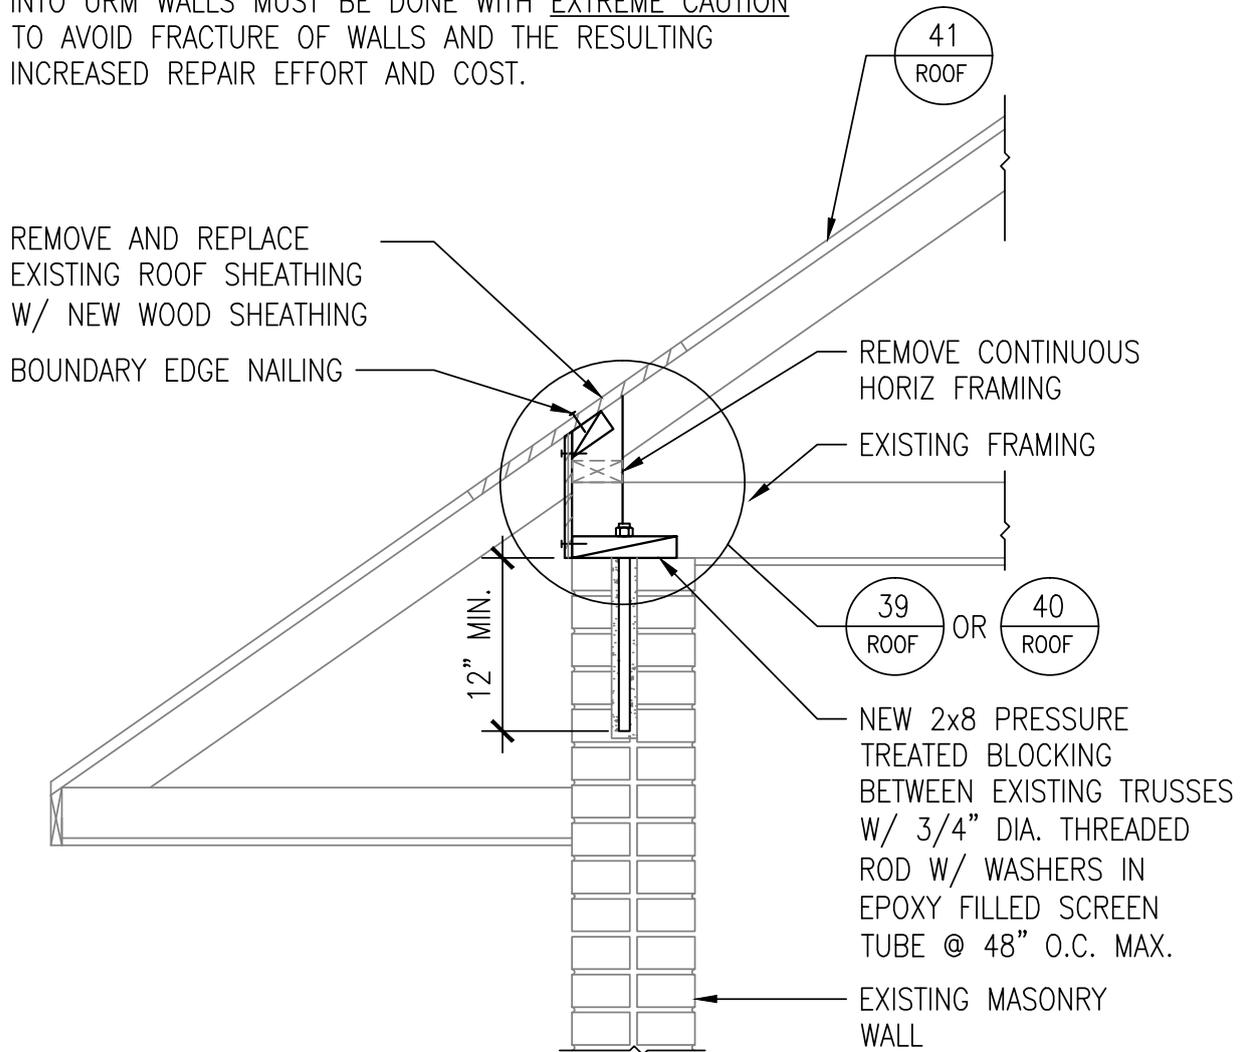
NOTE:
 FOR EASE OF INSTALLATION THE NEW WOOD MEMBERS CAN BE ASSEMBLED ON THE GROUND, LIFTED INTO PLACE AND THEN ATTACHED TO THE EXISTING WALL AND FRAMING.

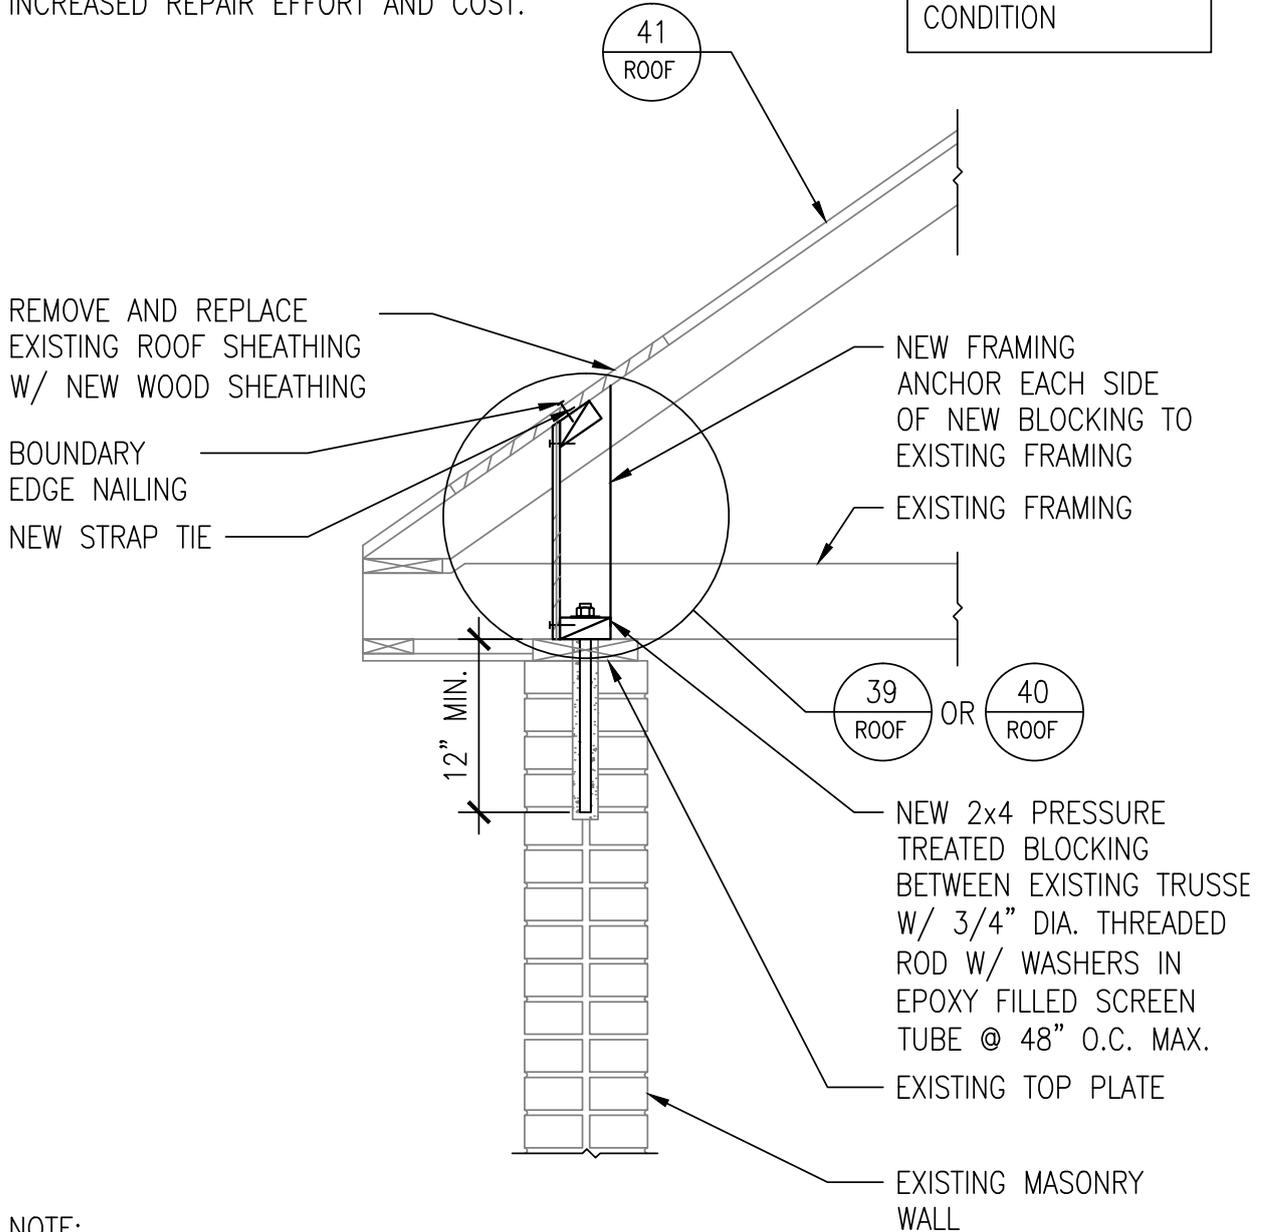
NOTE:
 FOR EASE OF INSTALLATION THE NEW WOOD MEMBERS CAN BE ASSEMBLED ON THE GROUND, LIFTED INTO PLACE AND THEN ATTACHED TO THE EXISTING WALL AND FRAMING.

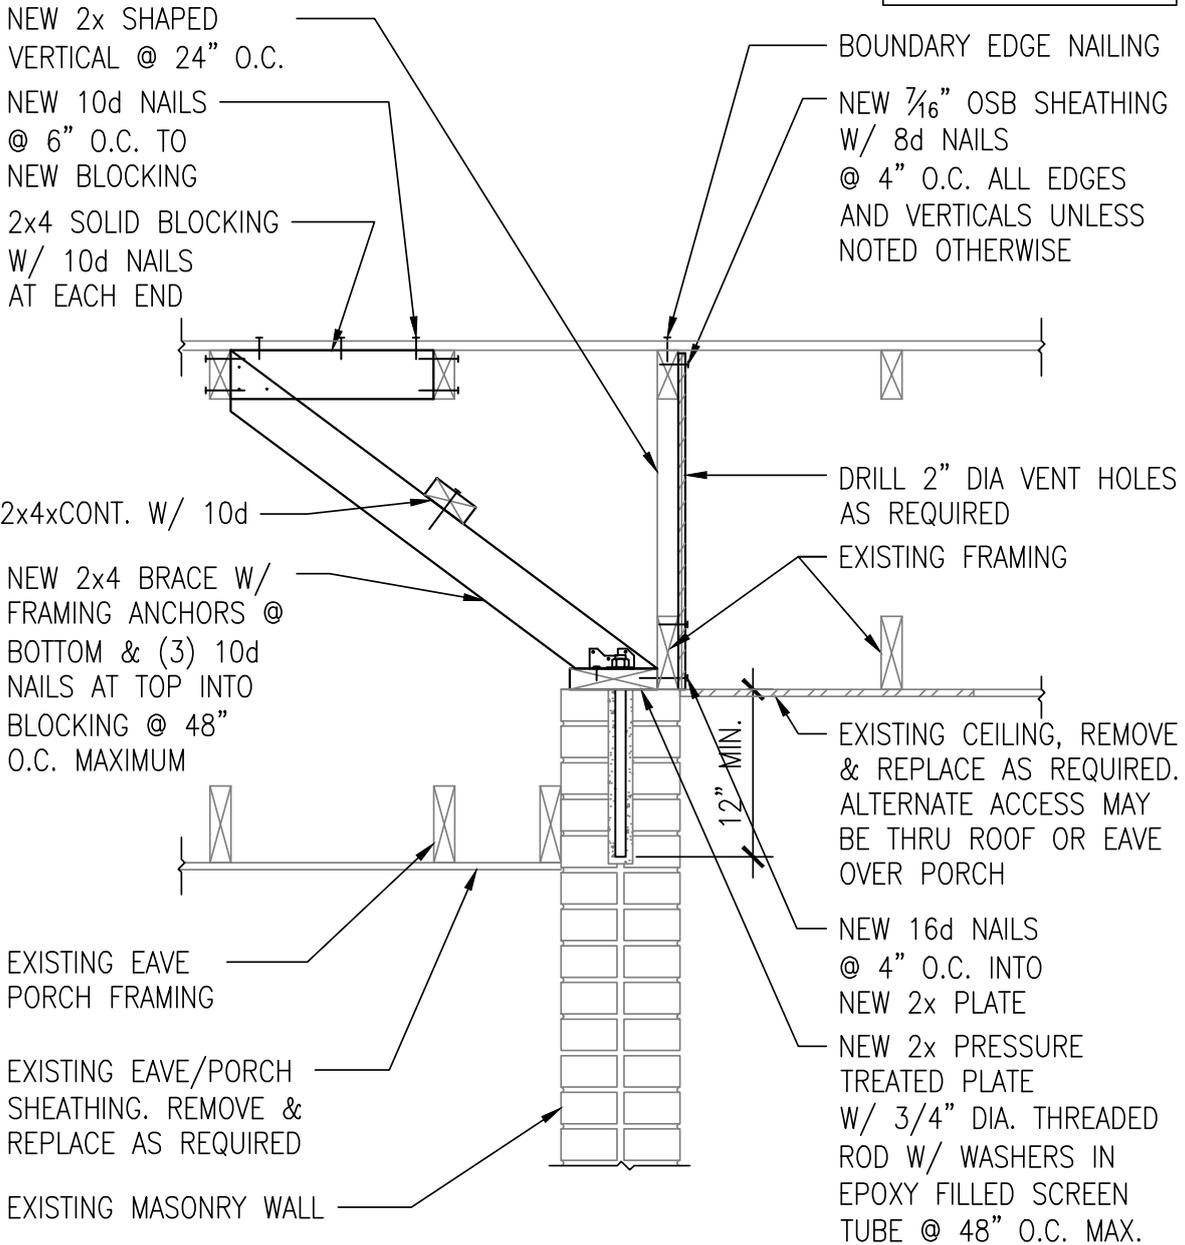
35a ROOF TO URM WALL ANCHORAGE W/
 ROOF JOISTS PARALLEL TO WALL

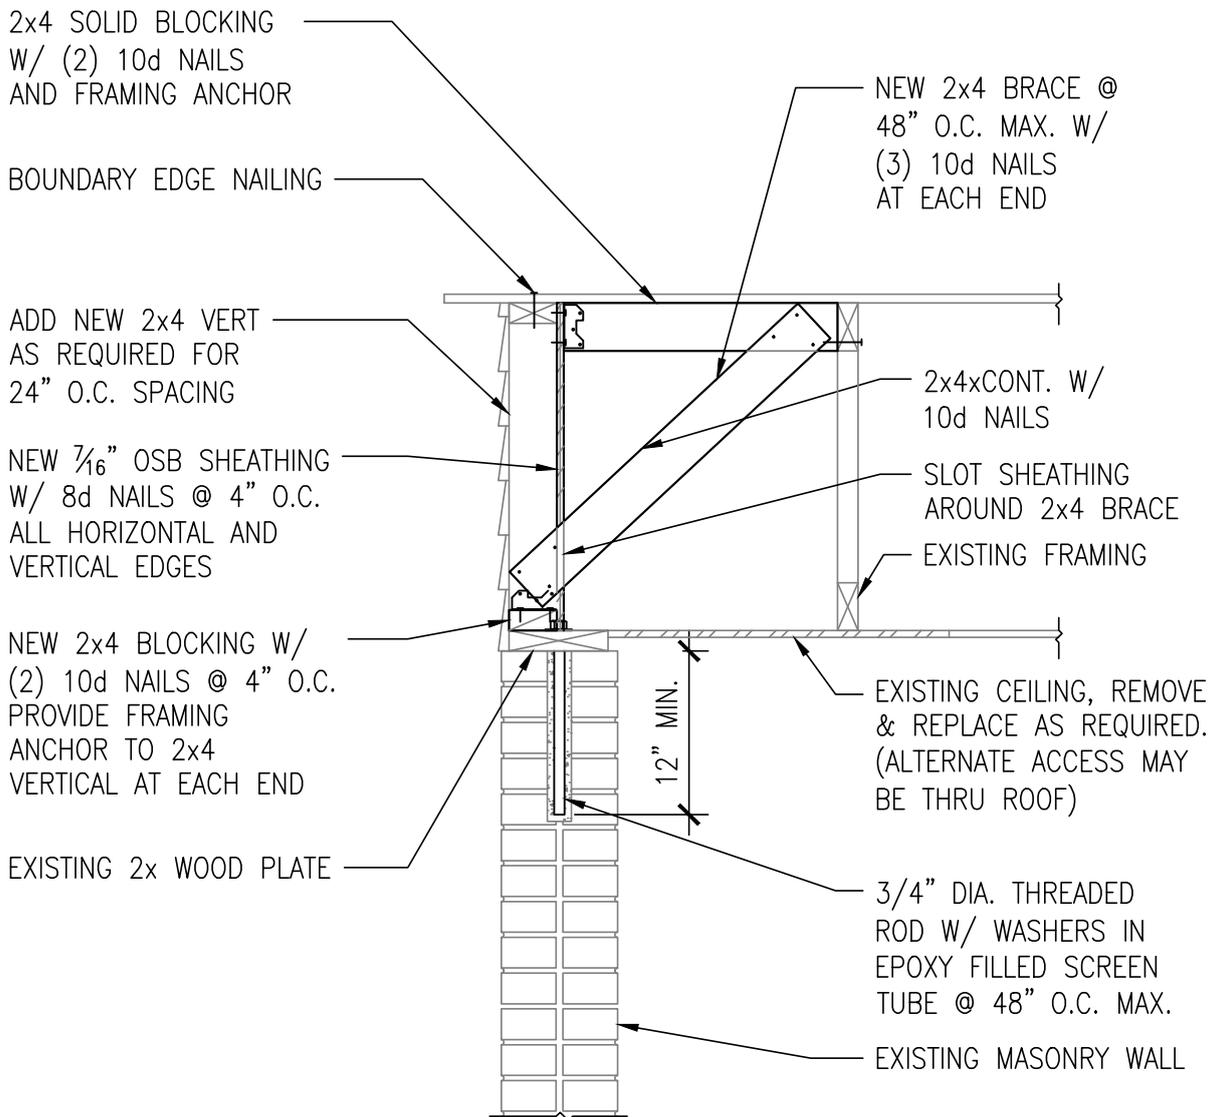
36a ROOF TO URM WALL ANCHORAGE W/
ROOF JOISTS PARALLEL TO WALL

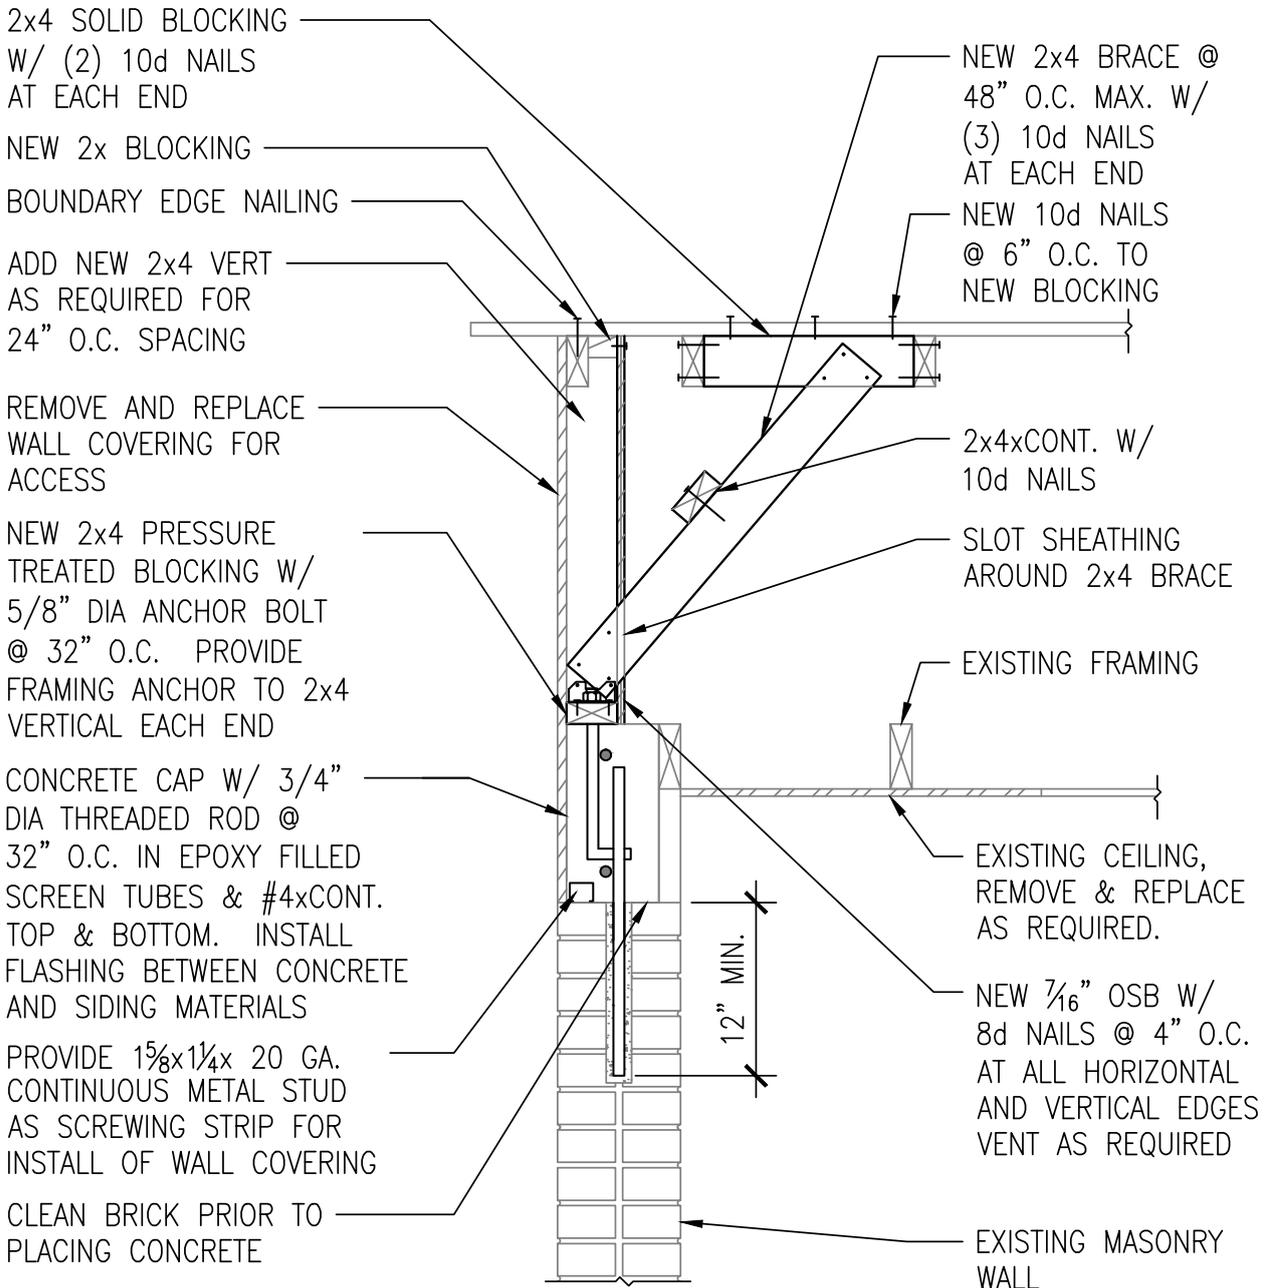
37a ROOF TO URM WALL ANCHORAGE W/ JOISTS PARALLEL TO WALL

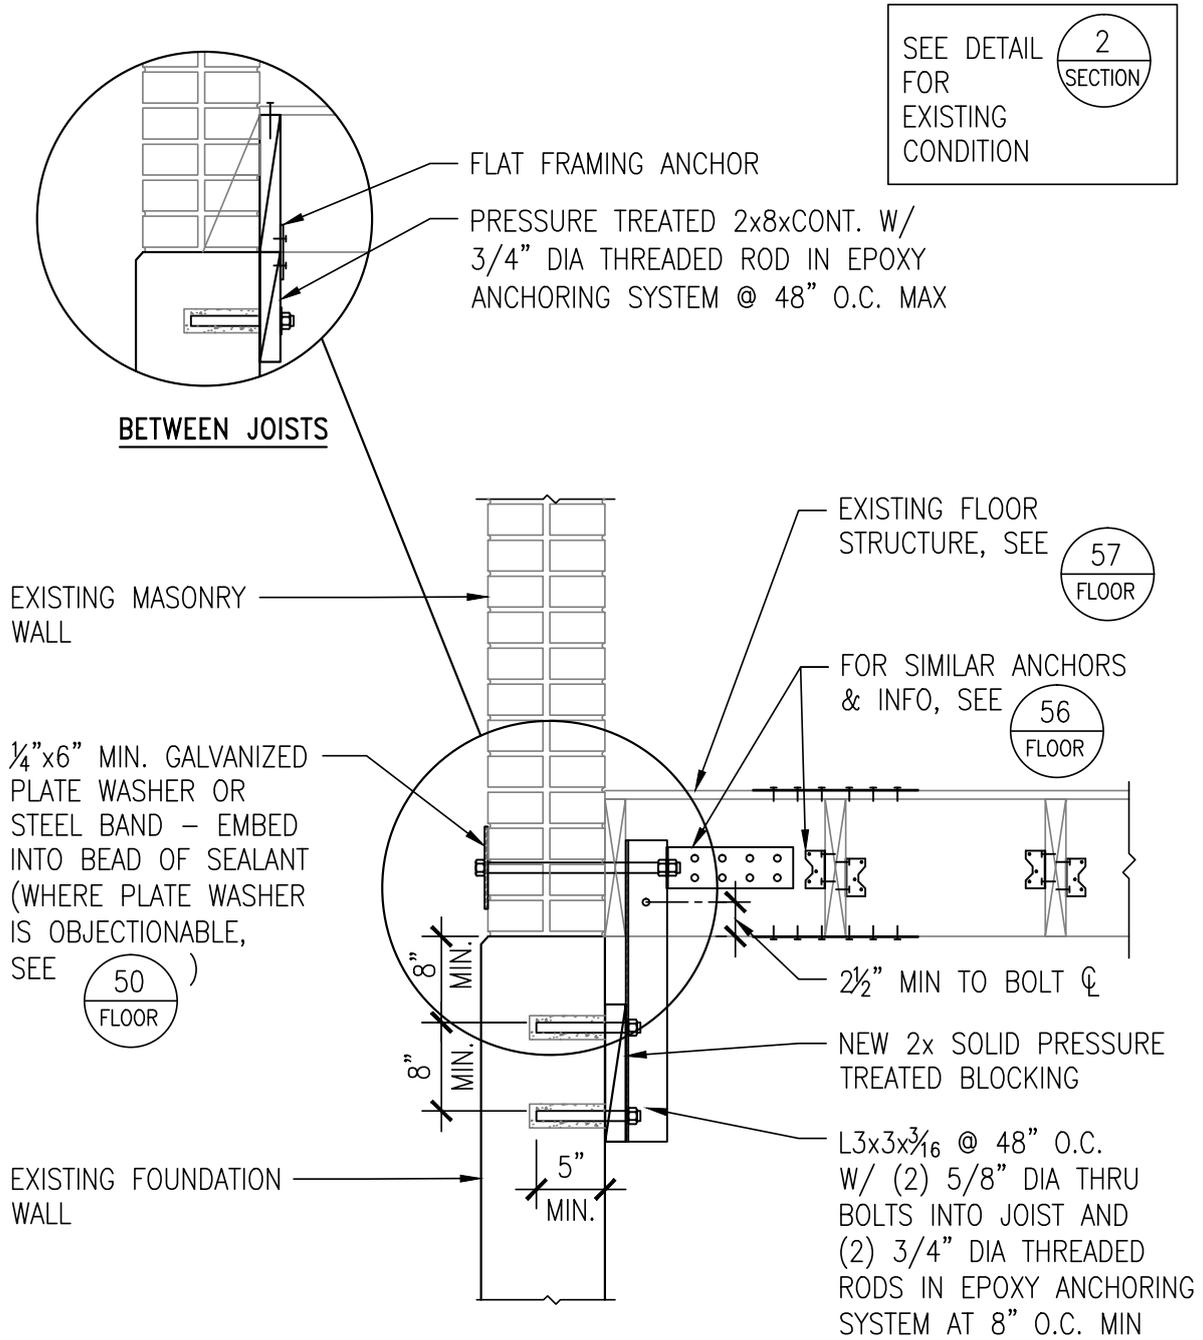
FLOOR TO URM WALL & FOUNDATION WALL ANCHORAGE W/JOISTS PARALLEL TO WALL FLOOR 54
